General Information

Make	Toyota	Model	Wigo
YOM	2018	Odo Meter Reading	75,737
Registration No.	MAO4199	Chassis No.	MHKA4DF5FJJ018900
CC	1.0	Transmission	A/T
Fuel Type	Gas	Type of Body	Hatchback
Colour	Black

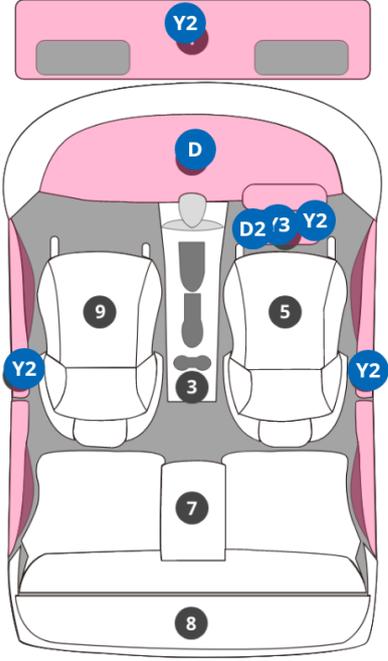
Interior Evaluation : B	Exterior Evaluation : C

<p>a : Cut, Fray d : Loose, Deformed k : Animal Hair s : Smell t : Cigarette Burns x : Defective y : Stain</p>

<p>A : Scratch AU : Scratch & Dent B : Modified C : Corrosion G : Stone chip P : Faded S : Rust SC : Rust & Corrosion U : Dent X : Defective Y : Crack, Gap</p>
<p>Remarks Dashboard - Traces of Adhesive Tape - Yes / (R) Front Trim - Grime - Small / (R) Front Floor Mat - Grime - Small / Ceiling - Grime - Small / Mat Other - Grime - Medium / (L) Front Trim - Grime - Small / (L) Front Floor Mat - Worked - Small</p>	<p>Remarks (L) Front Fender - Repair Traces - Yes / (L) Rear Door - Repair Traces - Yes / (R) Rear Fender - Repair Traces - Yes / (R) Mirror - Scratch - Small / (R) Front Door, Molding - Scratch & Dent - Medium / (R) Rear Door, Molding - Scratch - Small / (R) Front Fender, Molding - Scratch - Small / (R) Rear Fender, Molding - Scratch - Small / Trunk Hood, Rear Gate - Scratch - Medium / (L) Rear Door, Molding - Scratch - Minimal / (L) Mirror - Scratch - Minimal / (L) Front Fender, Molding - Scratch - Minimal / Bonnet, Headlight - Scratch - Small / Front Bumper, Grille, Lamps - Scratch & Dent - Medium</p>
