## General Information

| Make | Toyota | Model | Vios |
| YOM | 2024 | Odo Meter Reading | 17,090 |
| Registration No. | NHS3236 | Chassis No. | PA1B18F33R4260683 |

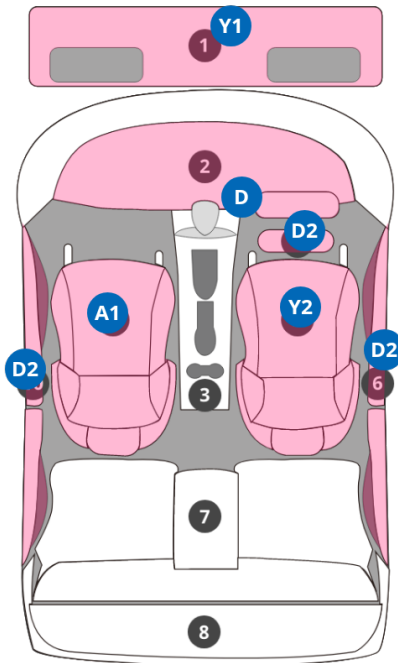
| Interior Evaluation : <b>B</b> | Exterior Evaluation : <b>E</b> |
| <p><b>Remarks</b></p> <p>(L) Front Floor Mat - Worked - Small / Ceiling - Grime - Minimal / (L) Front Trim - Worked - Small / (R) Front Trim - Worked - Small / Dashboard - Traces of Adhesive Tape - Yes / (L) Front Seat - Cut, Crack - Minimal / (R) Front Seat - Grime - Small</p> | <p><b>Remarks</b></p> <p>Member (Bolted) - Dent - Yes / (L) Front Door, Molding - Scratch &amp; Dent - Large / (L) Step, In-panel, Side Spoiler - Scratch &amp; Dent - Small / (L) Front Fender, Molding - Scratch - Small / Front Bumper, Grille, Lamps - Scratch - Small / (R) Front Fender, Molding - Scratch - Minimal / (R) Mirror - Scratch - Minimal / (R) Front Door, Molding - Scratch - Medium / (R) Rear Door, Molding - Scratch - Medium / (R) Rear Fender, Molding - Scratch &amp; Dent - Medium / Rear Bumper, Lamps, Panels - Scratch - Medium / (R) Step, In-panel, Side Spoiler - Scratch &amp; Dent - Small / (L) Mirror - Scratch - Minimal / (L) Rear Door, Molding - Scratch &amp; Dent - Minimal / (L) Rear Fender, Molding - Scratch - Small / Trunk Hood, Rear Gate - Scratch &amp; Dent - Small / Roof - Scratch &amp; Dent - Small / Bonnet, Headlight - Scratch &amp; Dent - Small</p> |

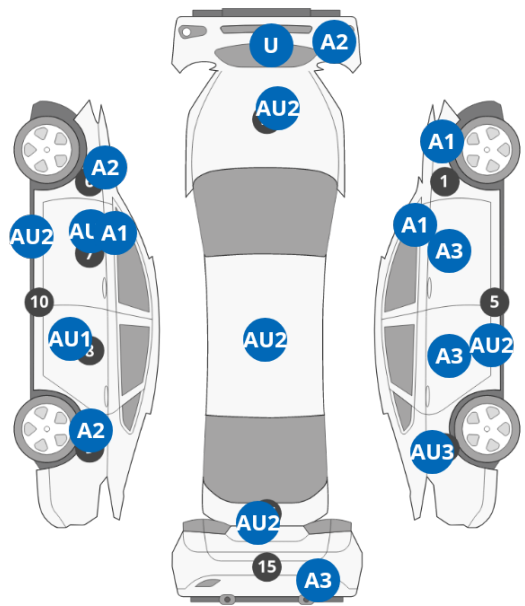
| Inspector Notes |
|---|
| With LTO plate, No warranty booklet and Spare tire and Jack and Tools, scratch headlight and tail light, Worn Tires. |
