## General Information

| Make | Toyota | Model | Vios |
| YOM | 2021 | Odo Meter Reading | 68,448 |

## Body / Panel Condition

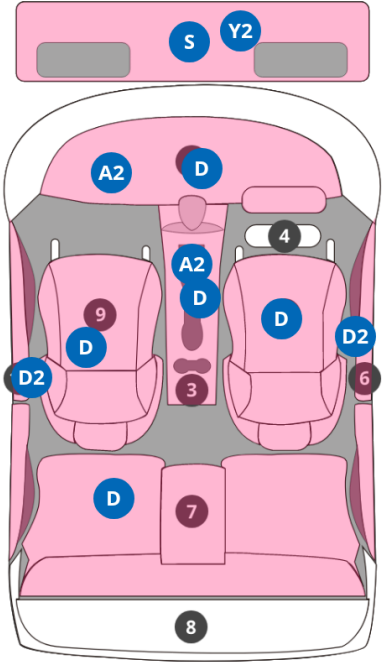
| Interior Evaluation : <span style="color: red;">C</span> | Exterior Evaluation : <span style="color: red;">E</span> |
| <b>Remarks</b><br>(R) Front Seat - Worn - Yes / (L) Front Seat - Worn - Yes / Rear Seat - Worn - Yes / (L) Front Trim - Worked - Small / (R) Front Trim - Worked - Small / Dashboard - Traces of Adhesive Tape - Yes / Dashboard - Worn, Scratch, Cut, Crack - Small / Console, Switches, Vents - Worn, Scratch, Cut, Crack - Small / Console, Switches, Vents - Traces of Adhesive Tape - Yes / Ceiling - Grime - Small / Overall Interior - Smell - Yes | <b>Remarks</b><br>(R) Front Door - Repair Traces - Yes / (R) Step - Repair Traces - Yes / (R) Front Fender - Repair Traces - Yes / Bonnet - Repair Traces - Yes / (L) Front Fender - Repair Traces - Yes / (L) Front Door - Repair Traces - Yes / (L) Step - Repair Traces - Yes / (L) Rear Door - Repair Traces - Yes / (L) Rear Fender - Repair Traces - Yes / Trunk Hood, Rear Gate - Repair Traces - Yes / Rear End Panel - Repair Traces - Yes / (R) Rear Fender - Repair Traces - Yes / (R) Rear Door - Repair Traces - Yes / Roof - Repair Traces - Yes / Trunk Hood, Rear Gate - Repair mark - Yes / (L) Rear Fender, Molding - Repair mark - Yes / (L) Rear Door, Molding - Repair mark - Yes / (L) Front Door, Molding - Repair mark - Yes / (L) Front Fender, Molding - Repair mark - Yes / Bonnet, Headlight - Repair mark - Yes / (R) Front Fender, Molding - Repair mark - Yes / (R) Front Door, Molding - Repair mark - Yes / (R) Rear Door, Molding - Repair mark - Yes / (R) Step, In-panel, Side Spoiler - Repair mark - Yes / Roof - Repair mark - Yes / (L) Step, In-panel, Side Spoiler - Repair mark - Yes / Member (Bolted) - Dent - Yes / Front Bumper, Grille, Lamps - Crack, Gap - Large / (L) Front Fender, Molding - Scratch - Minimal / (L) Front Door, Molding - Scratch & Dent - Small / (L) Rear Door, Molding - Scratch - Minimal / (L) Step, In-panel, Side Spoiler - Scratch & Dent - Small / (L) Rear Fender, Molding - Scratch - Small / Rear Bumper, Lamps, Panels - Scratch - Medium / Trunk Hood, Rear Gate - Scratch - Small / (R) Rear Fender, Molding - Repair mark - Yes / (R) Rear Fender, Molding - Scratch - Small / (R) Rear Door, Molding - Scratch & Dent - Small / (R) Step, In-panel, Side Spoiler - Scratch & Dent - Small / (R) Front Door, Molding - Scratch & Dent - Small / (R) Front Fender, Molding - Scratch & Dent - Small / (R) Mirror - Scratch - Minimal / (L) Mirror - Scratch - Minimal / Bonnet, Headlight - Scratch & Dent - Small / Roof - Scratch & Dent - Small |

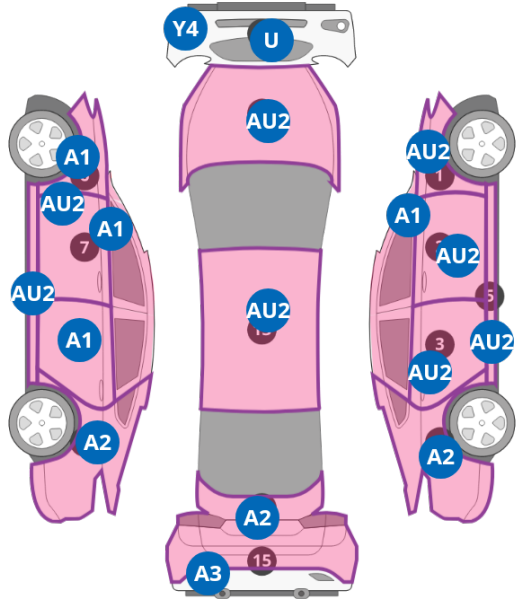
With LTO plate and Spare tire, No Tools and Jack and Warranty booklet, scratch and crack tail light and headlight, worn tires and Spare tire, No trunk cover, No reverse camera, No spare key, Abnormal vibration on engine, foul smell.
