## General Information

| Make | Toyota | Model | Innova |

## Body / Panel Condition

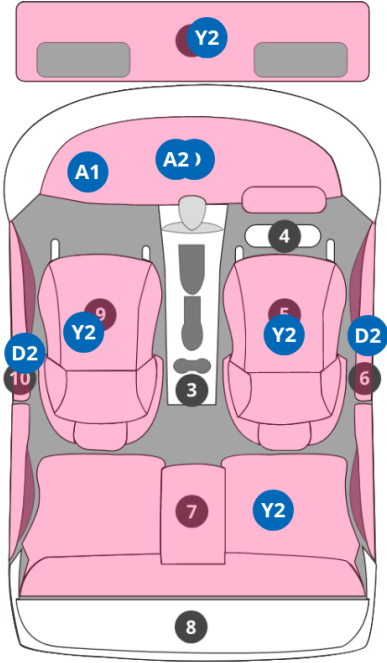
| Interior Evaluation : <b>B</b> | Exterior Evaluation : <b>E</b> |
| <b>Remarks</b><br>Dashboard - Traces of Adhesive Tape - Yes / (L) Front Seat - Grime - Small / (R) Front Seat - Grime - Small / Rear Seat - Grime - Small / Glove Box - Worn, Scratch, Cut, Crack - Minimal / (L) Front Trim - Worked - Small / (R) Front Trim - Worked - Small / Ceiling - Grime - Small / Steering Wheel - Worn, Peel, Crack - Small | <b>Remarks</b><br>(R) Front Door - Repair Traces - Yes / (R) Step - Repair Traces - Yes / (R) Front Fender - Repair Traces - Yes / Bonnet - Repair Traces - Yes / (L) Front Fender - Repair Traces - Yes / (L) Front Door - Repair Traces - Yes / (L) Step - Repair Traces - Yes / (L) Rear Door - Repair Traces - Yes / (L) Rear Fender - Repair Traces - Yes / Trunk Hood, Rear Gate - Repair Traces - Yes / (R) Rear Fender - Repair Traces - Yes / (R) Rear Door - Repair Traces - Yes / Roof - Repair Traces - Yes / Trunk Hood, Rear Gate - Repair mark - Yes / (L) Rear Door, Molding - Repair mark - Yes / (L) Rear Fender, Molding - Repair mark - Yes / (L) Front Door, Molding - Repair mark - Yes / (L) Front Fender, Molding - Repair mark - Yes / Bonnet, Headlight - Repair mark - Yes / (R) Front Fender, Molding - Repair mark - Yes / (R) Front Door, Molding - Repair mark - Yes / (R) Rear Door, Molding - Repair mark - Yes / (R) Rear Fender, Molding - Repair mark - Yes / (R) Step, In-panel, Side Spoiler - Repair mark - Yes / (L) Step, In-panel, Side Spoiler - Repair mark - Yes / Roof - Repair mark - Yes / Member (Bolted) - Dent - Yes / Front Bumper, Grille, Lamps - Scratch - Medium / (L) Front Fender, Molding - Scratch - Small / (L) Front Door, Molding - Scratch & Dent - Small / (L) Rear Door, Molding - Scratch & Dent - Medium / (L) Rear Fender, Molding - Scratch - Small / Rear Bumper, Lamps, Panels - Repair mark - Yes / Rear Bumper, Lamps, Panels - Scratch - Medium / (R) Rear Fender, Molding - Scratch - Large / (R) Rear Door, Molding - Scratch & Dent - Small / (R) Front Door, Molding - Scratch & Dent - Small / (R) Mirror - Scratch - Minimal / (R) Front Fender, Molding - Scratch - Small / Bonnet, Headlight - Scratch - Small / Roof - Scratch & Dent - Small / (L) Step, In-panel, Side Spoiler - Scratch & Dent - Small / (R) Step, In-panel, Side Spoiler - Scratch & Dent - Small / Trunk Hood, Rear Gate - Scratch - Small |
