## General Information

| Make | Toyota | Model | Wigo |
| YOM | 2023 | Odo Meter Reading | 33,689 |

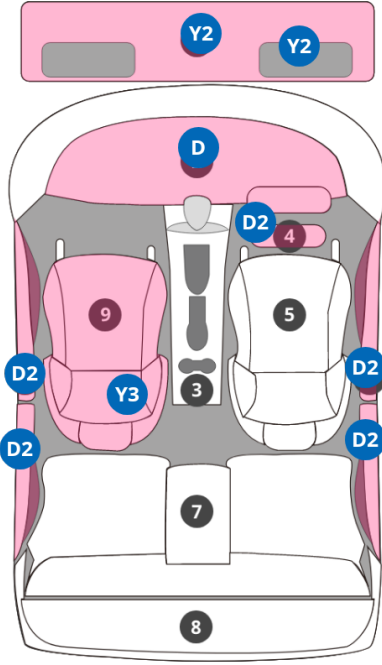
| Interior Evaluation : <span style="color: red;">C</span> | Exterior Evaluation : <span style="color: red;">E</span> |
| <p><b>Remarks</b><br/> Ceiling - Grime - Small / Dashboard - Traces of Adhesive Tape - Yes / (L) Front Seat - Grime - Medium / Sunvisor, Sunglass Holder - Grime - Small / (L) Front Floor Mat - Worked - Small / (L) Front Trim - Worked - Small / (R) Front Trim - Worked - Small / (R) Rear Trim - Worked - Small / (L) Rear Trim - Worked - Small</p> | <p><b>Remarks</b><br/> (L) Rear Fender, Molding - Scratch - Small / (L) Mirror - Scratch - Small / (R) Rear Fender, Molding - Scratch - Small / (R) Rear Door, Molding - Scratch - Large / (R) Front Door, Molding - Scratch - Medium / (R) Step, In-panel, Side Spoiler - Scratch &amp; Dent - Large / (R) Front Fender, Molding - Scratch &amp; Dent - Medium / (R) Mirror - Scratch - Small / Bonnet, Headlight - Scratch - Small / (L) Front Fender, Molding - Scratch - Small / (L) Front Door, Molding - Scratch - Small / (L) Rear Door, Molding - Scratch - Small / Rear Bumper, Lamps, Panels - Scratch - Small / Front Bumper, Grille, Lamps - Scratch &amp; Dent - Small</p> |

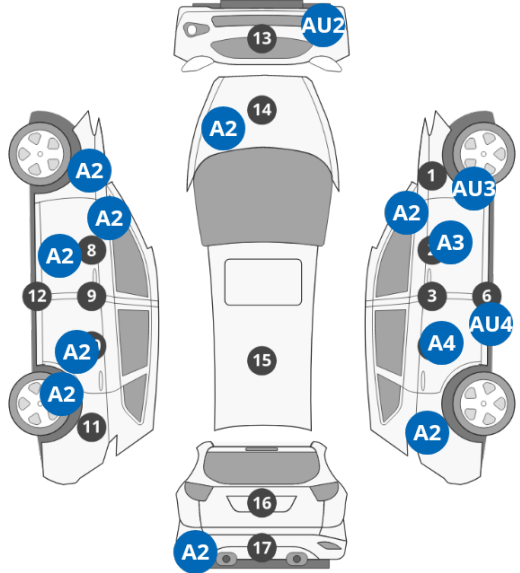
Gap at front and rear bumper. With warranty booklet, spare tire, jack and seat cover. Without tools. 1 key. With LTO plate.
