## General Information

| Make | Toyota | Model | Vios |
| YOM | 2023 | Odo Meter Reading | 17,427 |

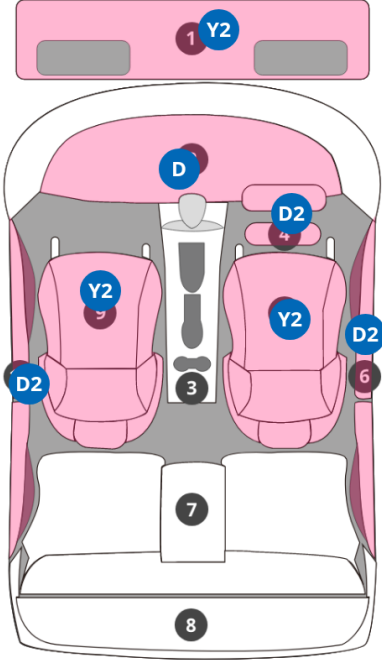
| Interior Evaluation : <b>B</b> | Exterior Evaluation : <b>E</b> |
| <b>Remarks</b><br>(L) Front Floor Mat - Worked - Small / (L) Front Seat - Grime - Small / (R) Front Seat - Grime - Small / (L) Front Trim - Worked - Small / (R) Front Trim - Worked - Small / Ceiling - Grime - Small / Dashboard - Traces of Adhesive Tape - Yes | <b>Remarks</b><br>(R) Front Door - Repair Traces - Yes / (R) Step - Repair Traces - Yes / (R) Front Fender - Repair Traces - Yes / Bonnet - Repair Traces - Yes / (L) Front Fender - Repair Traces - Yes / (L) Front Door - Repair Traces - Yes / (L) Step - Repair Traces - Yes / Trunk Hood, Rear Gate - Repair Traces - Yes / Trunk Hood, Rear Gate - Repair mark - Yes / (L) Step, In-panel, Side Spoiler - Repair mark - Yes / (L) Front Door, Molding - Repair mark - Yes / (L) Front Fender, Molding - Repair mark - Yes / Bonnet, Headlight - Repair mark - Yes / (R) Front Fender, Molding - Repair mark - Yes / (R) Step, In-panel, Side Spoiler - Repair mark - Yes / (R) Front Door, Molding - Repair mark - Yes / (L) Front Fender, Molding - Scratch - Small / (L) Front Door, Molding - Dent - Minimal / (L) Rear Door, Molding - Scratch & Dent - Minimal / (L) Rear Fender, Molding - Scratch - Small / (L) Step, In-panel, Side Spoiler - Scratch & Dent - Small / (L) Mirror - Scratch - Minimal / (R) Mirror - Scratch - Minimal / Member (Bolted) - Dent - Yes / Bonnet, Headlight - Scratch & Dent - Small / Front Bumper, Grille, Lamps - Scratch - Medium / (R) Front Fender, Molding - Scratch - Small / (R) Front Door, Molding - Scratch & Dent - Small / (R) Rear Door, Molding - Scratch & Dent - Minimal / (R) Step, In-panel, Side Spoiler - Scratch & Dent - Small / (R) Rear Fender, Molding - Scratch & Dent - Small / Trunk Hood, Rear Gate - Scratch & Dent - Small / Roof - Scratch & Dent - Small / Rear Bumper, Lamps, Panels - Scratch - Medium / Rear Bumper, Lamps, Panels - Repair mark - Yes |
