## General Information

| Make | Toyota | Model | Vios |
| Registration No. | DBP6359 | Chassis No. | PA1B18F32R426126 |

## Body / Panel Condition

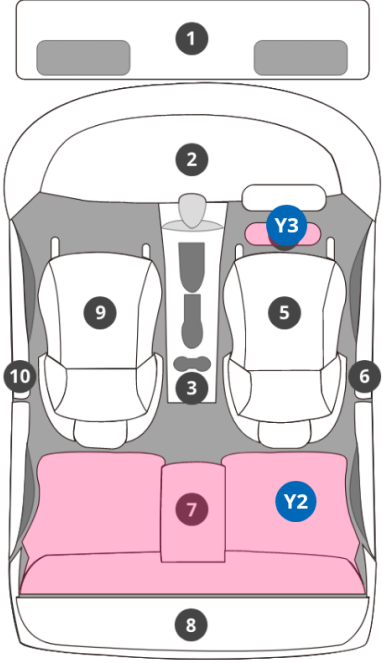
| Interior Evaluation : <b>B</b> | Exterior Evaluation : <b>B</b> |
|---|---|
| <p><b>Remarks</b><br/>Rear Seat - Grime - Small / (R) Front Floor Mat - Grime - Medium</p> | <p><b>Remarks</b><br/>(R) Front Door, Molding - Scratch - Minimal / (R) Rear Door, Molding - Scratch - Small / (R) Rear Fender, Molding - Scratch - Minimal / Rear Bumper, Lamps, Panels - Scratch - Minimal / (L) Front Fender, Molding - Scratch - Minimal / Front Bumper, Grille, Lamps - Scratch &amp; Dent - Medium / Bonnet, Headlight - Scratch - Minimal</p> |
