General Information

Make	Toyota	Model	Vios
YOM	2019	Odo Meter Reading	22,718
Registration No.	GAJ7937	Chassis No.	PA1B13F34J4072925
CC	1.3	Transmission	A/T
Fuel Type	Gas	Type of Body	Sedan
Colour	Black

Body / Panel Condition

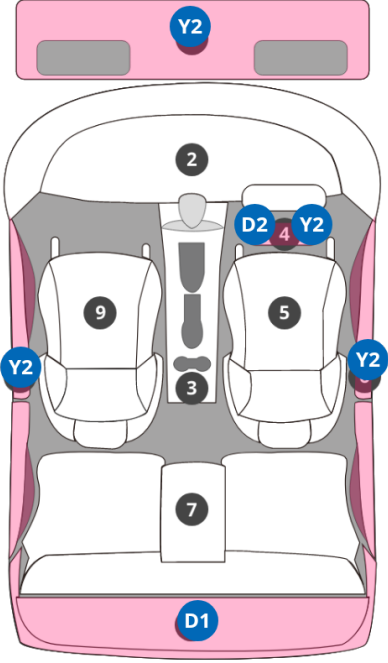
<p>a : Cut, Fray d : Loose, Deformed k : Animal Hair s : Smell t : Cigarette Burns x : Defective y : Stain</p>

<p>A : Scratch AU : Scratch & Dent B : Modified C : Corrosion G : Stone chip P : Faded S : Rust SC : Rust & Corrosion U : Dent X : Defective Y : Crack, Gap</p>
<p>Remarks Ceiling - Grime - Small / (R) Front Trim - Grime - Small / (L) Front Trim - Grime - Small / Trunk Room - Worked - Minimal / (L) Front Floor Mat - Worked - Small / (R) Front Floor Mat - Grime - Small / Room Mirror - Missing - Yes</p>	<p>Remarks Bonnet - Repair Traces - Yes / (L) Rear Fender - Repair Traces - Yes / (R) Rear Fender - Repair Traces - Yes / (R) Mirror - Scratch - Small / (R) Mirror - Crack - Damaged / (L) Rear Fender, Molding - Scratch - Small / Rear Bumper, Lamps, Panels - Scratch - Small / Front Bumper, Grille, Lamps - Scratch - Small / (R) Rear Door, Molding - Scratch - Minimal / (L) Rear Door, Molding - Scratch - Minimal / (L) Front Door, Molding - Scratch - Minimal / (R) Front Door, Molding - Scratch - Minimal / Roof - Scratch - Small / (L) Front Fender, Molding - Scratch - Small / Bonnet, Headlight - Scratch - Small</p>
