## General Information

| Make | Nissan | Model | Navara |
| YOM | 2020 | Odo Meter Reading | 79,825 |
| Registration No. | LAG5480 | Chassis No. | MNTCC2D23Z0075164 |

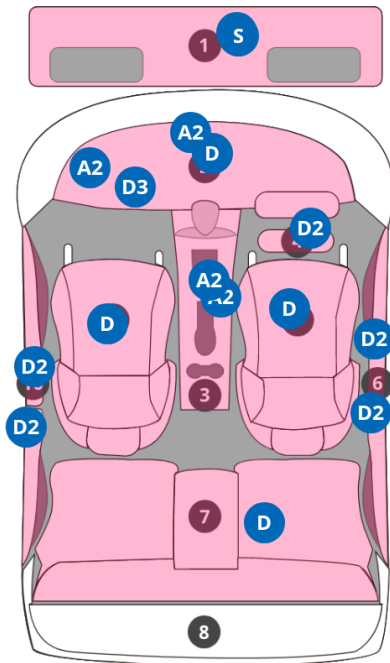
| Interior Evaluation : <span>E</span> | Exterior Evaluation : <span>E</span> |
|---|---|
| <b>Remarks</b><br>Ceiling - Grime - Large / Overall Interior - Worn as per age - Yes / Overall Interior - Smell - Yes / Dashboard - Traces of Adhesive Tape - Yes / Dashboard - Worn, Scratch, Cut, Crack - Small / Glove Box - Loose, Deformed - Medium / Steering Wheel - Worn, Peel, Crack - Small / Console, Switchs, Vents - Worn, Scratch, Cut, Crack - Small / Knobs - Worn, Peel, Crack - Small / Room Mirror - Stuck - Yes / Display, Audio System - Stuck - Yes / (L) Front Seat - Worn - Yes / (R) Front Seat - Worn - Yes / Rear Seat - Worn - Yes / (L) Front Trim - Worked - Small / (R) Front Trim - Worked - Small / (L) Front Floor Mat - Worked - Small / (L) Rear Trim - Worked - Small / (R) Rear Trim - Worked - Small | <b>Remarks</b><br>(R) Front Door - Repair Traces - Yes / (R) Step - Repair Traces - Yes / (R) Front Fender - Repair Traces - Yes / Bonnet - Repair Traces - Yes / (L) Front Fender - Repair Traces - Yes / (L) Front Door - Repair Traces - Yes / (L) Step - Repair Traces - Yes / (L) Rear Door - Repair Traces - Yes / (L) Rear Corner Panel - Repair Traces - Yes / (R) Rear Door - Repair Traces - Yes / Roof - Repair Traces - Yes / Roof - Replaced - Yes / Rear Gate - Repair mark - Yes / (L) Side Gate - Repair mark - Yes / (L) Rear Door, Molding - Repair mark - Yes / (L) Front Door, Molding - Repair mark - Yes / (L) Front Fender, Molding - Repair mark - Yes / Bonnet, Headlight - Repair mark - Yes / Member (Bolted) - Dent - Yes / (R) Front Fender, Molding - Repair mark - Yes / (R) Front Door, Molding - Repair mark - Yes / (R) Rear Door, Molding - Repair mark - Yes / (R) Side Gate - Repair mark - Yes / Roof - Repair mark - Yes / (R) Step, In-panel, Side Spoiler - Repair mark - Yes / (L) Step, In-panel, Side Spoiler - Repair mark - Yes / Cab Back Panel - Repair mark - Yes / (R) Front Fender, Molding - Scratch - Medium / (R) Front Door, Molding - Scratch - Large / (R) Mirror - Scratch - Minimal / (R) Rear Door, Molding - Scratch - Medium / (R) Side Gate - Scratch - Large / Rear Gate - Scratch - Medium / Rear Bumper, Lamps, Panels - Scratch & Dent - Medium / (L) Side Gate - Scratch - Large / (L) Rear Door, Molding - Scratch & Dent - Medium / (L) Front Door, Molding - Scratch - Medium / (L) Front Fender, Molding - Scratch - Medium / Bonnet, Headlight - Scratch & Dent - Medium / Front Bumper, Grille, Lamps - Scratch - Medium / Roof - Scratch & Dent - Small / Cab Back Panel - Scratch - Small / Cargo Bed Floor - Scratch - Small |

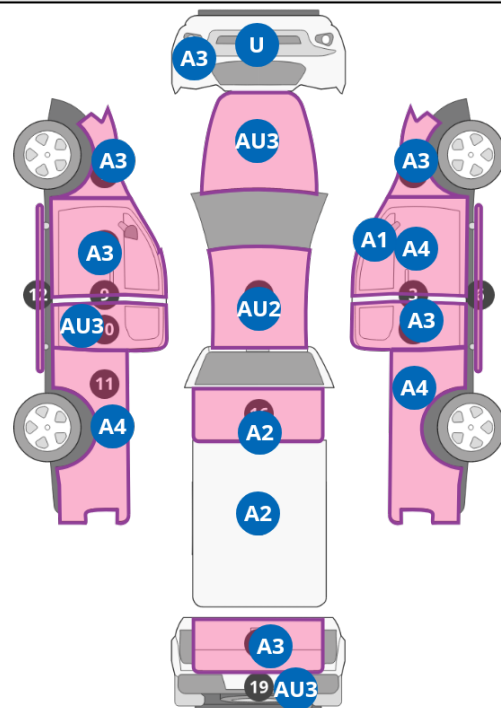
| Interior Evaluation : <span>E</span> | Exterior Evaluation : <span>E</span> |
|---|---|
| <b>Remarks</b><br>Right Front Pillar - Traces of Bending, or Marks of Panel Repair ? - Yes / Front Cross Member Support - Condition of Welding ? - Yes / Right Front Inside Panel (Front Side) - Traces of Bending, or Marks of Panel Repair ? - Yes / Left Front Inside Panel (Front Side) - Traces of Bending, or Marks of Panel Repair ? - Yes / Left Front Pillar - Traces of Bending, or Marks of Panel Repair ? - Yes / Left Center Pillar - Traces of Bending, or Marks of Panel Repair ? - Yes / Right Center Pillar - Traces of Bending, or Marks of Panel Repair ? - Yes | <b>Remarks</b><br>Retractable Mirror - Issue - Yes / Warning Lamps - Issue - Yes / Power Window (each) - Stuck, Gap - Yes / Door Lock - Issue - Yes / Power Steering - Issue - Yes / Battery - Weak - Yes / Reverse Camera - N/A - Yes / Parking Brake - Function - Weak / Turn Signal, Hazard Flasher - Issue - Yes / Head Light, High Beam - Issue - Yes / Lamps (Brake, Tail, Fog) - Issue - Yes / Wiper - Function - Weak / Spare Key - Issue - Unexist |
