General Information

Make	Toyota	Model	FJ Cruiser
YOM	2015	Odo Meter Reading	35,579
Registration No.	ABN3172	Chassis No.	JTEBU11F1FK216910
CC	4.0	Transmission	A/T
Fuel Type	Gas	Type of Body	Wagon
Colour	White

Body / Panel Condition

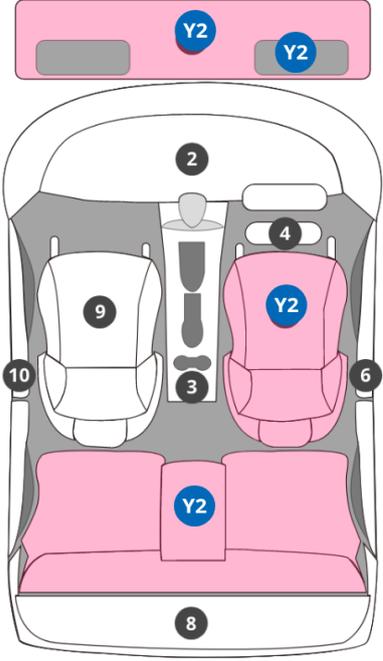
Interior Evaluation : A	Exterior Evaluation : B

<p>a : Cut, Fray d : Loose, Deformed k : Animal Hair s : Smell t : Cigarette Burns x : Defective y : Stain</p>

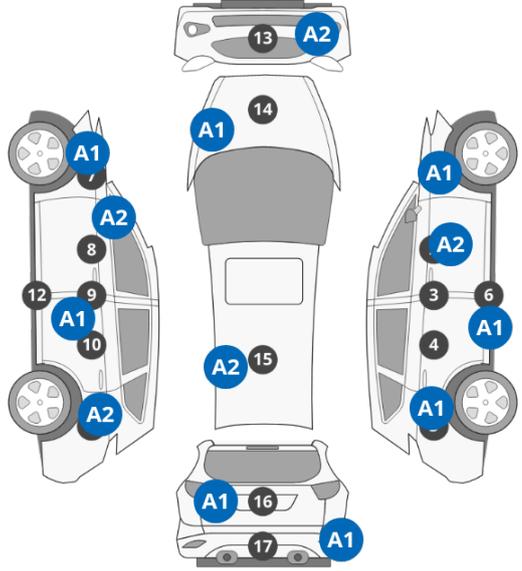
<p>A : Scratch AU : Scratch & Dent B : Modified C : Corrosion G : Stone chip P : Faded S : Rust SC : Rust & Corrosion U : Dent X : Defective Y : Crack, Gap</p>
<p>Remarks Ceiling - Grime - Small / (R) Front Seat - Grime - Small / Sunvisor, Sunglass Holder - Grime - Small / Rear Seat - Grime - Small</p>	<p>Remarks Front Bumper, Grille, Lamps - Scratch - Small / (L) Front Fender, Molding - Scratch - Minimal / Bonnet, Headlight - Scratch - Minimal / (L) Mirror - Scratch - Small / (L) Rear Fender, Molding - Scratch - Small / (L) Rear Door, Molding - Scratch - Minimal / (R) Rear Fender, Molding - Scratch - Minimal / Rear Bumper, Lamps, Panels - Scratch - Minimal / (R) Front Fender, Molding - Scratch - Minimal / (R) Front Door, Molding - Scratch - Small / (R) Step, In-panel, Side Spoiler - Scratch - Minimal / Trunk Hood, Rear Gate - Scratch - Minimal / Roof - Scratch - Small</p>
