## General Information

| Make | Toyota | Model | Vios |
| YOM | 2024 | Odo Meter Reading | 16,482 |
| Registration No. | CCC1207 | Chassis No. | PA1B18F36P4230705 |

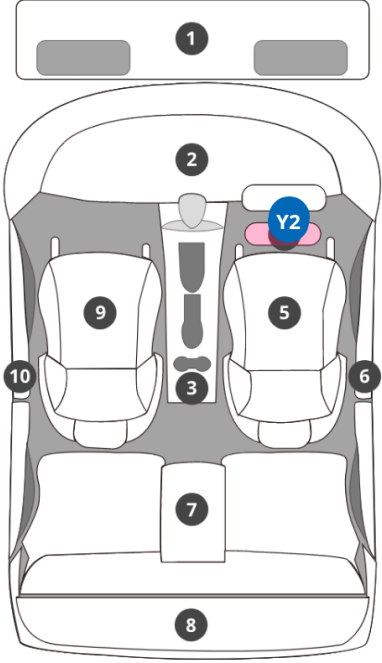
| Interior Evaluation : <b>A</b> | Exterior Evaluation : <b>B</b> |
|---|---|
| <p><b>Remarks</b><br/>Mat Other - Grime - Small / (L) Front Floor Mat - Grime - Small</p> | <p><b>Remarks</b><br/>(R) Front Fender, Molding - Scratch - Minimal / (R) Front Door, Molding - Scratch - Minimal / (R) Rear Door, Molding - Scratch &amp; Dent - Small / (R) Rear Fender, Molding - Scratch - Minimal / Rear Bumper, Lamps, Panels - Scratch &amp; Dent - Small / (L) Rear Fender, Molding - Scratch - Minimal / Roof - Scratch - Small / (L) Front Door, Molding - Scratch - Small / (L) Front Fender, Molding - Scratch &amp; Dent - Medium / Bonnet, Headlight - Scratch - Minimal / Front Bumper, Grille, Lamps - Scratch - Minimal</p> |
