## General Information

| Make | Toyota | Model | Raize |
| Registration No. | CCK2503 | Chassis No. | MHKAB1BA2RJ093661 |

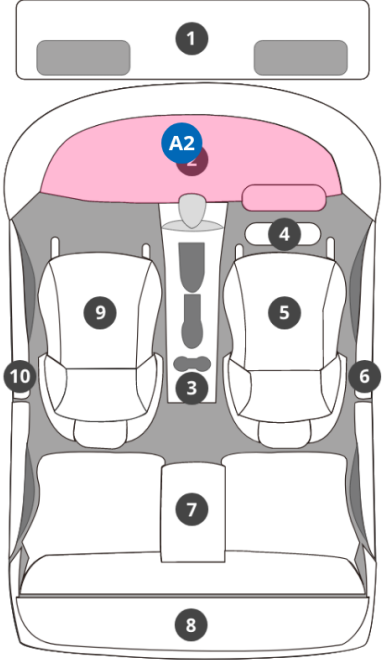
| Interior Evaluation : <b>A</b> | Exterior Evaluation : <b>A</b> |
|---|---|
| <b>Remarks</b><br>Dashboard - Worn, Scratch, Cut, Crack - Small | <b>Remarks</b><br>Front Bumper, Grille, Lamps - Crack, Gap - Small |

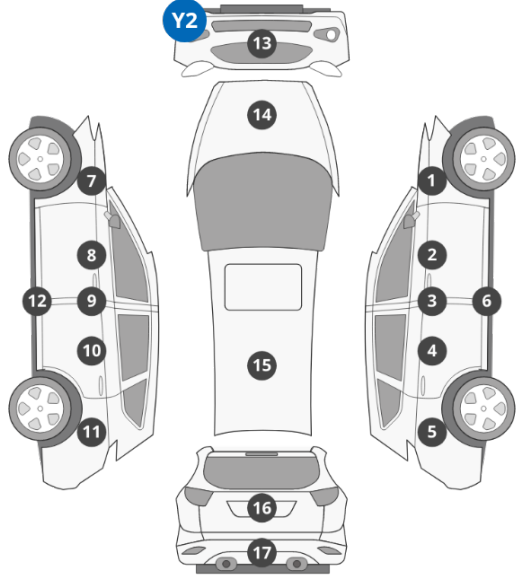
With Lto plate, with warranty booklet, 1key, with jack and spare tire, no tools, scratches on headlight, dirt mark on exterior
