General Information

Make	Toyota	Model	Vios
YOM	2024	Odo Meter Reading	38,060
Registration No.	CCD1313	Chassis No.	PA1B18F35R4243920
CC	1.3	Transmission	CVT
Fuel Type	Gas	Type of Body	Sedan
Colour	Silver

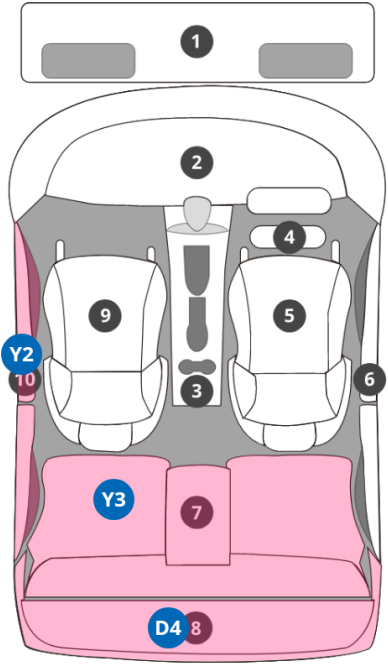
Interior Evaluation : C	Exterior Evaluation : C

<p>a : Cut, Fray d : Loose, Deformed k : Animal Hair s : Smell t : Cigarette Burns x : Defective y : Stain</p>

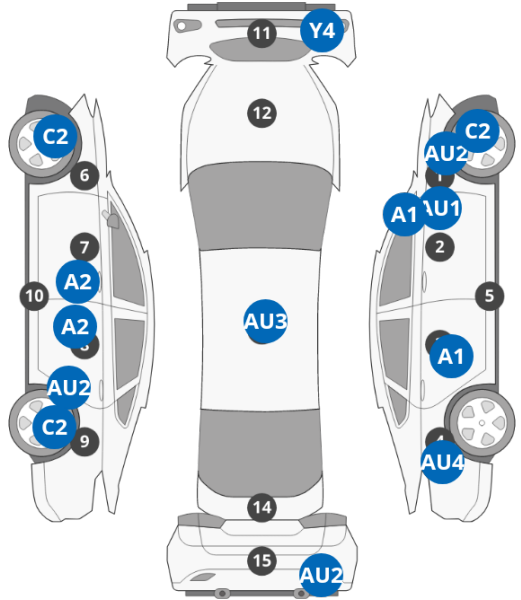
<p>A : Scratch AU : Scratch & Dent B : Modified C : Corrosion G : Stone chip P : Faded S : Rust SC : Rust & Corrosion U : Dent X : Defective Y : Crack, Gap</p>
<p>Remarks (L) Front Trim - Grime - Small / Trunk Room - Worked - Large / Rear Seat - Grime - Medium</p>	<p>Remarks (R) Front Fender, Molding - Scratch & Dent - Small / (R) Front Door, Molding - Scratch & Dent - Minimal / (R) Mirror - Scratch - Minimal / (R) Rear Door, Molding - Scratch - Minimal / (R) Rear Fender, Molding - Scratch & Dent - Large / Rear Bumper, Lamps, Panels - Scratch & Dent - Small / (L) Rear Fender, Molding - Scratch & Dent - Small / (L) Rear Door, Molding - Scratch - Small / (L) Front Door, Molding - Scratch - Small / Roof - Scratch & Dent - Medium / Front Bumper, Grille, Lamps - Crack, Gap - Large / (L) Front Wheel, Cover - Scratch, Corrosion - Small / (L) Rear Wheel, Cover - Scratch, Corrosion - Small / (R) Front Wheel, Cover - Scratch, Corrosion - Small</p>
