## General Information

| Make | Toyota | Model | Raize |
| YOM | 2023 | Odo Meter Reading | 32,744 |
| Registration No. | CBI7509 | Chassis No. | MHKAA1BA3PJ075203 |

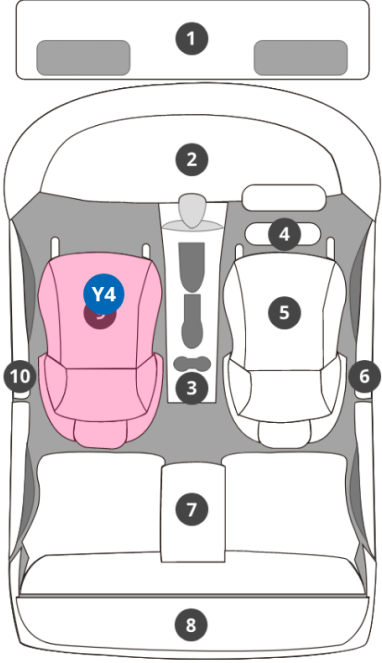
| Interior Evaluation : <b>C</b> | Exterior Evaluation : <b>B</b> |
| <b>Remarks</b><br>(L) Front Seat - Grime - Large | <b>Remarks</b><br>(R) Mirror - Scratch - Minimal / (L) Front Fender, Molding - Scratch - Minimal / Front Bumper, Grille, Lamps - Scratch - Minimal / Rear Bumper, Lamps, Panels - Crack, Gap - Medium |

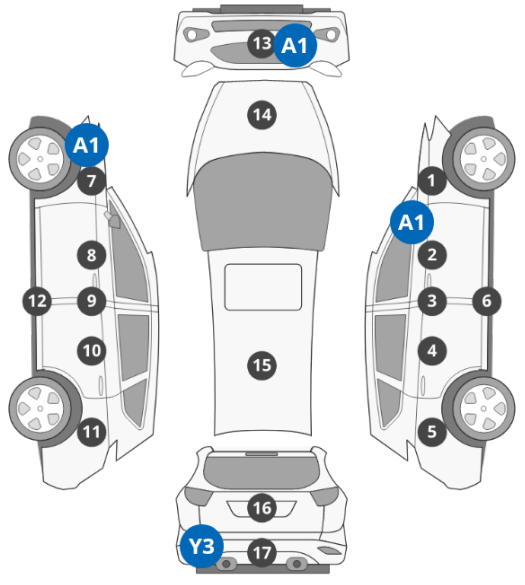
| Inspector Notes |
|---|
| With Lto plate, with warranty booklet, with spare tire and jack, no tools, 2 keys, Crack tail light, scratches headlight |
