## General Information

| Make | Toyota | Model | Vios |

## Body / Panel Condition

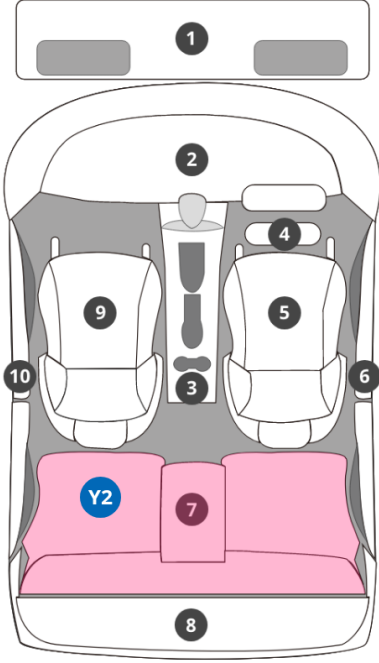
| Interior Evaluation : <b>A</b> | Exterior Evaluation : <b>C</b> |
| <b>Remarks</b><br>Rear Seat - Grime - Small | <b>Remarks</b><br>(L) Front Door - Repair Traces - Yes / (L) Rear Fender - Repair Traces - Yes / (R) Front Fender, Molding - Scratch - Minimal / (R) Rear Door, Molding - Scratch - Medium / (R) Rear Fender, Molding - Scratch - Medium / Rear Bumper, Lamps, Panels - Scratch - Minimal / (L) Rear Fender, Molding - Repair mark - Yes / (L) Rear Door, Molding - Scratch & Dent - Small / (L) Front Door, Molding - Scratch - Minimal / Bonnet, Headlight - Scratch - Minimal / Front Bumper, Grille, Lamps - Scratch - Medium |
