General Information

Make	Toyota	Model	Vios
YOM	2025	Odo Meter Reading	8,290
Registration No.	CCG8843	Chassis No.	PA1B18F32S4286519
CC	1.3	Transmission	CVT
Fuel Type	Gas	Type of Body	Sedan
Colour	Blue

Body / Panel Condition

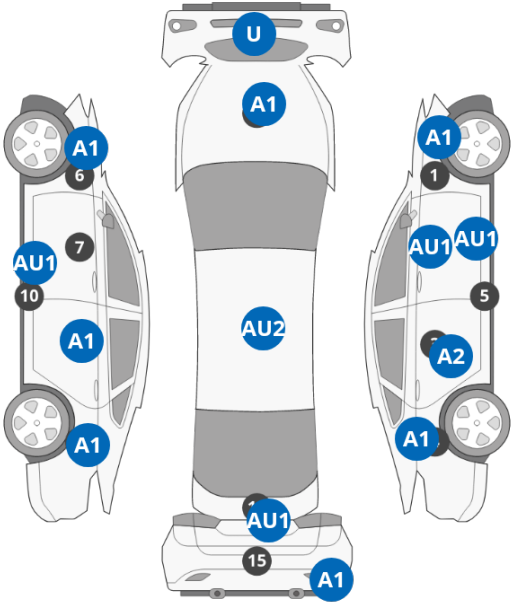
<p>A : Scratch AU : Scratch & Dent B : Modified C : Corrosion G : Stone chip P : Faded S : Rust SC : Rust & Corrosion U : Dent X : Defective Y : Crack, Gap</p>
Remarks Defects not found	Remarks Member (Bolted) - Dent - Yes / Bonnet, Headlight - Scratch - Minimal / (L) Rear Door, Molding - Scratch - Minimal / (L) Step, In-panel, Side Spoiler - Scratch & Dent - Minimal / (L) Front Fender, Molding - Scratch - Minimal / Trunk Hood, Rear Gate - Scratch & Dent - Minimal / Rear Bumper, Lamps, Panels - Scratch - Minimal / (L) Rear Fender, Molding - Scratch - Minimal / Roof - Scratch & Dent - Small / (R) Front Fender, Molding - Scratch - Minimal / (R) Front Door, Molding - Scratch & Dent - Minimal / (R) Rear Door, Molding - Scratch - Small / (R) Step, In-panel, Side Spoiler - Scratch & Dent - Minimal / (R) Rear Fender, Molding - Scratch - Minimal

Inspector Notes
With LTO plate, No warranty booklet and Sparetire and Jack and Tools, No Spare key, Scratch headlight and tail light, foul smell, worn tires.
