General Information

Make	Toyota	Model	Vios
YOM	2024	Odo Meter Reading	18,041
Registration No.	NKE3937	Chassis No.	PA1B18F39R4257433
CC	1.3	Transmission	CVT
Fuel Type	Gas	Type of Body	Sedan
Colour	Blue

Body / Panel Condition

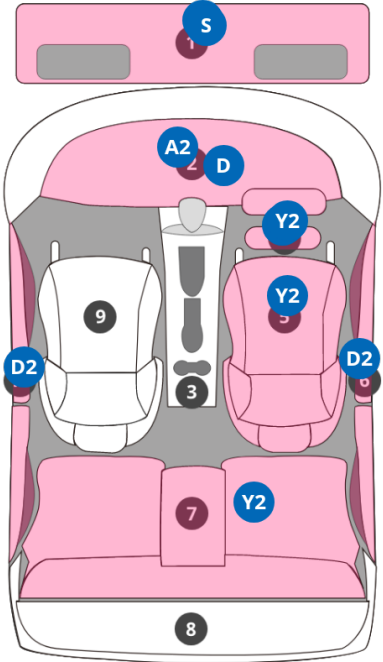
Interior Evaluation : C	Exterior Evaluation : D

<p>a : Cut, Fray d : Loose, Deformed k : Animal Hair s : Smell t : Cigarette Burns x : Defective y : Stain</p>

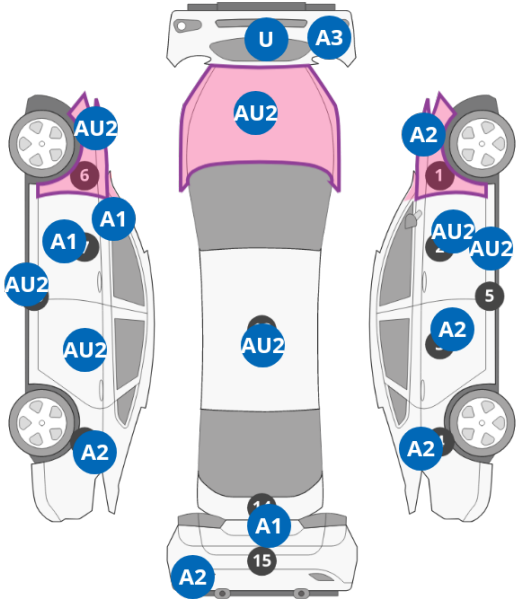
<p>A : Scratch AU : Scratch & Dent B : Modified C : Corrosion G : Stone chip P : Faded S : Rust SC : Rust & Corrosion U : Dent X : Defective Y : Crack, Gap</p>
<p>Remarks Ceiling - Grime - Minimal / (L) Front Floor Mat - Worked - Small / (R) Front Floor Mat - Grime - Small / Mat Other - Grime - Small / (L) Front Trim - Worked - Small / (R) Front Trim - Worked - Small / Dashboard - Worn, Scratch, Cut, Crack - Small / Dashboard - Traces of Adhesive Tape - Yes / Rear Seat - Grime - Small / (R) Front Seat - Grime - Small / Overall Interior - Smell - Yes</p>	<p>Remarks (R) Front Fender - Repair Traces - Yes / Bonnet - Repair Traces - Yes / (L) Front Fender - Repair Traces - Yes / (L) Front Fender, Molding - Repair mark - Yes / (R) Front Fender, Molding - Repair mark - Yes / Bonnet, Headlight - Repair mark - Yes / Member (Bolted) - Dent - Yes / Front Bumper, Grille, Lamps - Scratch - Medium / (R) Front Fender, Molding - Scratch - Small / (R) Front Door, Molding - Scratch & Dent - Small / (R) Rear Door, Molding - Scratch - Small / (R) Step, In-panel, Side Spoiler - Scratch & Dent - Small / (R) Rear Fender, Molding - Scratch - Small / Trunk Hood, Rear Gate - Scratch - Minimal / Roof - Scratch & Dent - Small / Bonnet, Headlight - Scratch & Dent - Small / Rear Bumper, Lamps, Panels - Scratch - Small / (L) Rear Fender, Molding - Scratch - Small / (L) Rear Door, Molding - Scratch & Dent - Small / (L) Front Door, Molding - Scratch - Minimal / (L) Front Fender, Molding - Scratch & Dent - Small / (L) Mirror - Scratch - Minimal / (L) Step, In-panel, Side Spoiler - Scratch & Dent - Small</p>
