## General Information

| Make | Toyota | Model | Raize |

## Body / Panel Condition

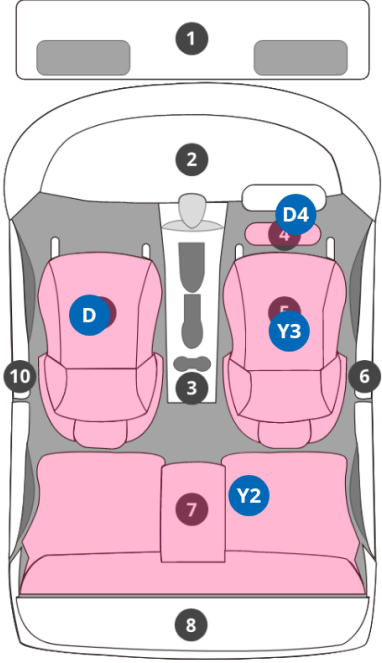
| Interior Evaluation : <span style="color: red;">C</span> | Exterior Evaluation : <span style="color: red;">C</span> |
|---|---|
| <b>Remarks</b><br>(L) Front Floor Mat - Worked - Large / (L) Front Seat - Worn - Yes / (R) Front Seat - Grime - Medium / Rear Seat - Grime - Small | <b>Remarks</b><br>(L) Rear Fender, Molding - Scratch - Minimal / (L) Rear Door, Molding - Scratch & Dent - Small / (L) Front Door, Molding - Scratch & Dent - Minimal / (L) Step, In-panel, Side Spoiler - Scratch - Minimal / (L) Front Fender, Molding - Dent - Minimal / (L) Mirror - Scratch - Minimal / Member (Bolted) - Dent - Yes / Bonnet, Headlight - Scratch & Dent - Minimal / Front Bumper, Grille, Lamps - Scratch - Small / (R) Front Fender, Molding - Scratch - Small / (R) Front Door, Molding - Scratch - Small / (R) Rear Door, Molding - Scratch & Dent - Small / (R) Rear Fender, Molding - Scratch - Minimal / (R) Step, In-panel, Side Spoiler - Scratch - Small / Trunk Hood, Rear Gate - Scratch & Dent - Small / Rear Bumper, Lamps, Panels - Scratch - Small / Roof - Scratch & Dent - Small |

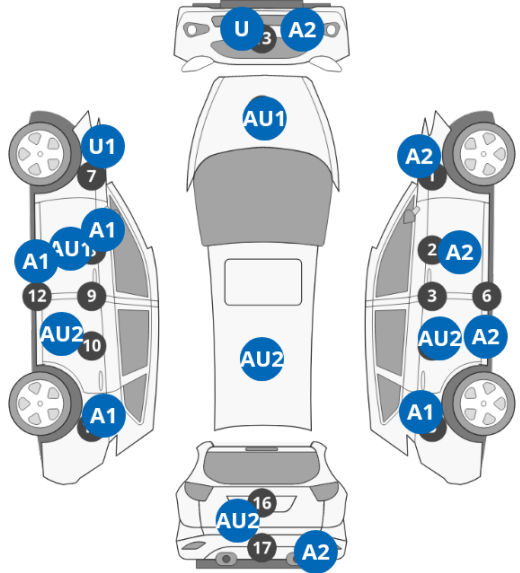
With LTO plate and Sparetire, No Tools and Jack and Warranty booklet, scratch headlight and tail light, no spare key, Abnormal vibration on engine, foul smell, worn tires, adhesive marks on vehicle.
