## General Information

| Make | Toyota | Model | Vios |
| Registration No. | CAZ9236 | Chassis No. | PA1B18F37R4240288 |

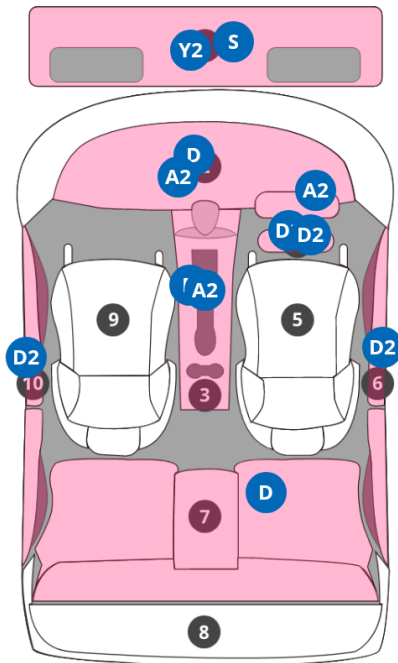
| Interior Evaluation : <b>C</b> | Exterior Evaluation : <b>E</b> |
| <p><b>Remarks</b></p> <p>Ceiling - Grime - Small / Overall Interior - Smell - Yes / (L) Front Floor Mat - Worked - Small / Mat Other - Worked - Small / (L) Front Trim - Worked - Small / (R) Front Trim - Worked - Small / Dashboard - Traces of Adhesive Tape - Yes / Dashboard - Worn, Scratch, Cut, Crack - Small / Console, Switchs, Vents - Traces of Adhesive Tape - Yes / Console, Switchs, Vents - Worn, Scratch, Cut, Crack - Small / Glove Box - Worn, Scratch, Cut, Crack - Small / Rear Seat - Worn - Yes</p> | <p><b>Remarks</b></p> <p>Member (Bolted) - Dent - Yes / (L) Rear Fender, Molding - Scratch &amp; Dent - Large / Rear Bumper, Lamps, Panels - Scratch - Large / (L) Rear Door, Molding - Scratch &amp; Dent - Small / (L) Front Door, Molding - Scratch &amp; Dent - Small / (L) Step, In-panel, Side Spoiler - Scratch &amp; Dent - Minimal / (L) Front Fender, Molding - Scratch - Small / (L) Mirror - Scratch - Minimal / Front Bumper, Grille, Lamps - Repair mark - Yes / Front Bumper, Grille, Lamps - Scratch - Medium / Bonnet, Headlight - Scratch &amp; Dent - Small / (R) Front Fender, Molding - Scratch - Small / (R) Front Door, Molding - Scratch - Minimal / (R) Rear Door, Molding - Scratch - Small / (R) Step, In-panel, Side Spoiler - Scratch &amp; Dent - Small / (R) Rear Fender, Molding - Scratch - Small / (R) Mirror - Scratch - Minimal / Roof - Scratch &amp; Dent - Small / Trunk Hood, Rear Gate - Scratch - Small</p> |

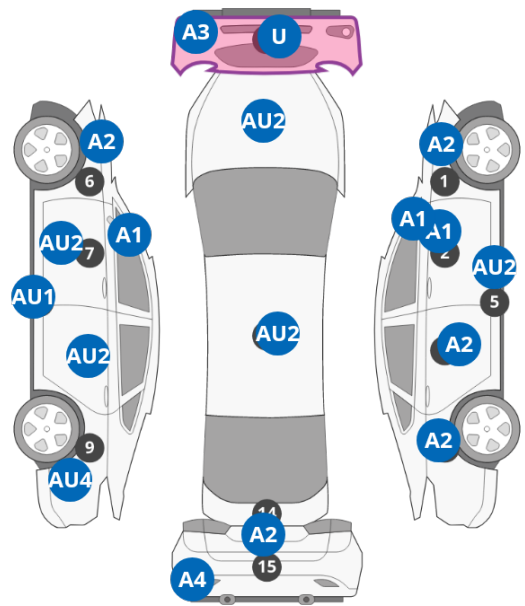
| Inspector Notes |
|---|
| <p>With LTO plate, No warranty booklet and Sparetire and Jack and Tools, No Spare key, Scratch headlight and tail light, Worn Tires, adhesive marks on vehicle, foul smell,worn tires.</p> |
