## General Information

| Make | Toyota | Model | Vios |
| Registration No. | CCG6355 | Chassis No. | PA1B18F3XR4278016 |

## Overall Evaluation :

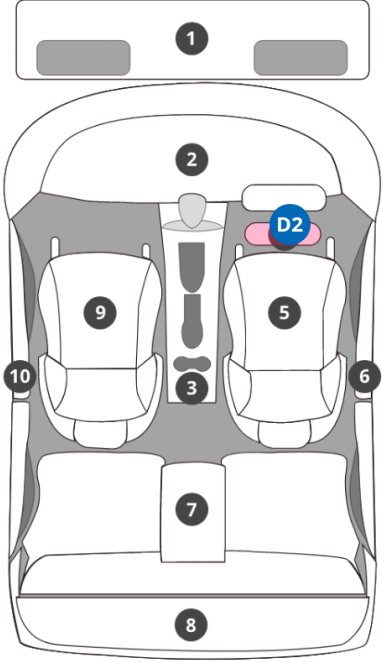
| Interior Evaluation : <b>A</b> | Exterior Evaluation : <b>C</b> |
| <b>Remarks</b><br>(L) Front Floor Mat - Worked - Small | <b>Remarks</b><br>Member (Bolted) - Dent - Yes / (R) Front Fender, Molding - Scratch - Minimal / (R) Front Door, Molding - Scratch & Dent - Minimal / (R) Rear Door, Molding - Scratch - Small / (R) Step, In-panel, Side Spoiler - Scratch & Dent - Minimal / Bonnet, Headlight - Scratch & Dent - Small / Front Bumper, Grille, Lamps - Scratch - Small / (L) Front Fender, Molding - Scratch - Minimal / (L) Front Door, Molding - Scratch & Dent - Minimal / (L) Rear Door, Molding - Scratch - Small / (L) Step, In-panel, Side Spoiler - Scratch & Dent - Minimal / (L) Rear Fender, Molding - Scratch - Minimal / (R) Rear Fender, Molding - Scratch & Dent - Minimal / (R) Mirror - Scratch - Minimal / (L) Mirror - Scratch - Minimal / Roof - Scratch & Dent - Small / Rear Bumper, Lamps, Panels - Scratch - Small / Trunk Hood, Rear Gate - Scratch & Dent - Small |
