## General Information

| Make | Toyota | Model | Vios |

## Body / Panel Condition

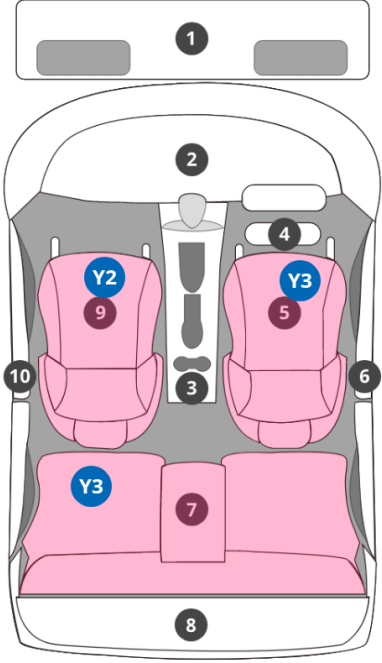
| <b>Interior Evaluation :</b> <b>B</b> | <b>Exterior Evaluation :</b> <b>B</b> |
| <b>Remarks</b><br>(R) Front Seat - Grime - Medium / Rear Seat - Grime - Medium / (L) Front Seat - Grime - Small | <b>Remarks</b><br>Front Bumper, Grille, Lamps - Scratch - Minimal / Rear Bumper, Lamps, Panels - Scratch & Dent - Medium / Trunk Hood, Rear Gate - Dent - Small |

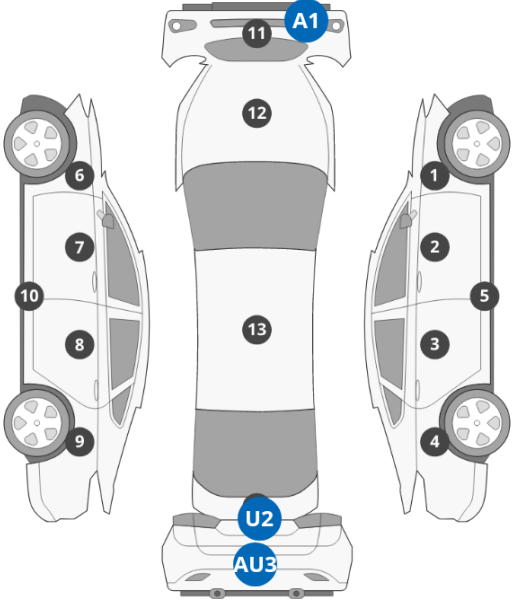
| with warranty booklets/No spare tire/jack and tools/hairline scratches around the vehicle/ trunk hood was drilled |
