## General Information

| Make | Toyota | Model | Innova |
| Registration No. | CMB5649 | Chassis No. | PA2JA8EM9M0089052 |

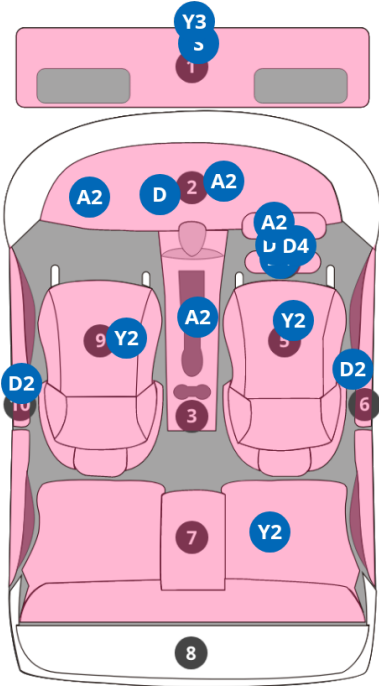
| Interior Evaluation : <b>E</b> | Exterior Evaluation : <b>E</b> |
| <p><b>Remarks</b></p> <p>Overall Interior - Smell - Yes / Ceiling - Grime - Medium / Mat Other - Worked - Large / (R) Front Seat - Grime - Small / Rear Seat - Grime - Small / (L) Front Seat - Grime - Small / (R) Front Floor Mat - Worked - Small / (L) Front Floor Mat - Worked - Large / Console, Switches, Vents - Worn, Scratch, Cut, Crack - Small / Dashboard - Worn, Scratch, Cut, Crack - Small / Dashboard - Traces of Adhesive Tape - Yes / Steering Wheel - Worn, Peel, Crack - Small / Glove Box - Worn, Scratch, Cut, Crack - Small / (L) Front Trim - Worked - Small / (R) Front Trim - Worked - Small</p> | <p><b>Remarks</b></p> <p>(R) Front Fender - Repair Traces - Yes / Bonnet - Repair Traces - Yes / (L) Front Fender - Repair Traces - Yes / Trunk Hood, Rear Gate - Repair Traces - Yes / (L) Front Fender, Molding - Repair mark - Yes / Bonnet, Headlight - Repair mark - Yes / (R) Front Fender, Molding - Repair mark - Yes / Member (Bolted) - Dent - Yes / Trunk Hood, Rear Gate - Repair mark - Yes / (L) Rear Door, Molding - Scratch &amp; Dent - Small / Front Bumper, Grille, Lamps - Crack, Gap - Medium / (R) Front Fender, Molding - Scratch - Medium / (R) Mirror - Scratch - Minimal / (R) Front Door, Molding - Scratch &amp; Dent - Minimal / (R) Rear Door, Molding - Scratch - Medium / (R) Step, In-panel, Side Spoiler - Scratch &amp; Dent - Small / (R) Rear Fender, Molding - Scratch - Medium / Rear Bumper, Lamps, Panels - Scratch - Large / Trunk Hood, Rear Gate - Scratch &amp; Dent - Small / (L) Rear Fender, Molding - Scratch - Small / (L) Front Door, Molding - Scratch &amp; Dent - Small / (L) Step, In-panel, Side Spoiler - Scratch &amp; Dent - Small / (L) Mirror - Scratch - Minimal / (L) Front Fender, Molding - Scratch &amp; Dent - Minimal / Bonnet, Headlight - Scratch - Medium / Roof - Scratch &amp; Dent - Medium</p> |

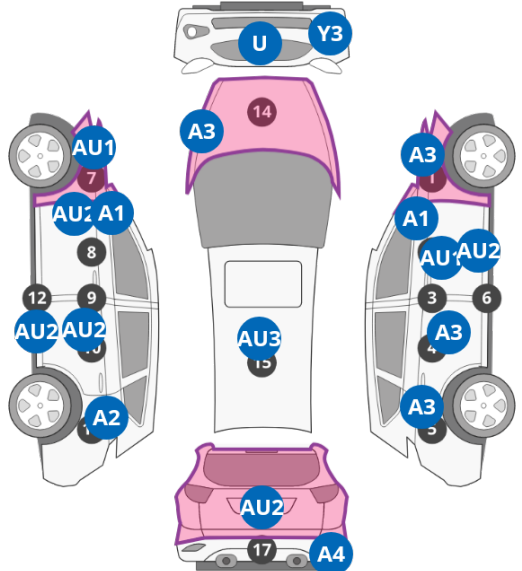
| Inspector Notes |
|---|
| With LTO plate and Spare tire, No Tools and Jack and Warranty booklet, scratch headlight and tail light, Worn Tires and Spare tire, foul smell, possible flooded, warning lamps on, Aircon issue, Room light issue, plate light issue, no reverse camera. |
