## General Information

| Make | Toyota | Model | Avanza |
| Registration No. | NKL2177 | Chassis No. | MHFAA1BY0R0036010 |

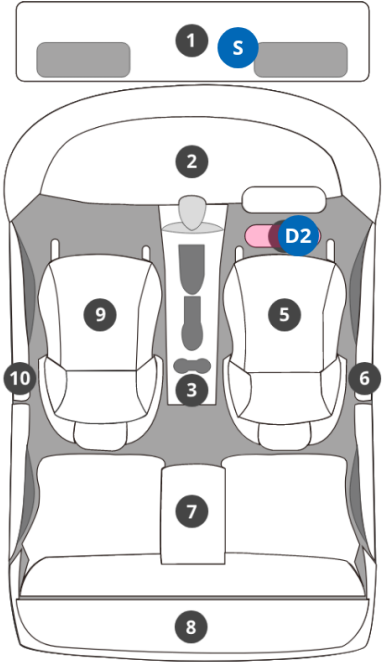
| Interior Evaluation : <b>B</b> | Exterior Evaluation : <b>B</b> |
|---|---|
| <b>Remarks</b><br>(L) Front Floor Mat - Worked - Small / Overall Interior - Smell - Yes | <b>Remarks</b><br>Member (Bolted) - Dent - Yes / Front Bumper, Grille, Lamps - Scratch - Small / (R) Front Door, Molding - Scratch - Small / (R) Rear Fender, Molding - Scratch - Minimal / Bonnet, Headlight - Scratch - Small / (L) Front Fender, Molding - Scratch - Small / (L) Front Door, Molding - Scratch & Dent - Small / (L) Rear Door, Molding - Scratch - Small / (L) Mirror - Scratch - Minimal / (R) Mirror - Scratch - Minimal / Rear Bumper, Lamps, Panels - Scratch - Small / Trunk Hood, Rear Gate - Scratch & Dent - Small |

with LTO plate and Sparetire, No Tools and Jack and Warranty booklet, No spare key, worn tires, Scratch headlight and tail light, foul smell.
