General Information

Make	Toyota	Model	Veloz
YOM	2025	Odo Meter Reading	10,676
Registration No.	NKL7604	Chassis No.	MHFAB1BY0R3128049
CC	1.5	Transmission	CVT
Fuel Type	Gas	Type of Body	Wagon
Colour	Black

Body / Panel Condition

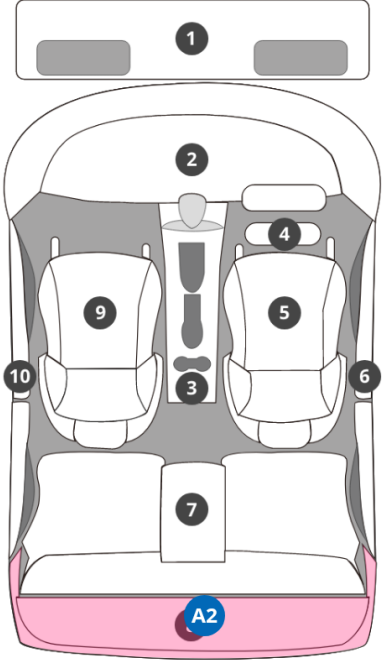
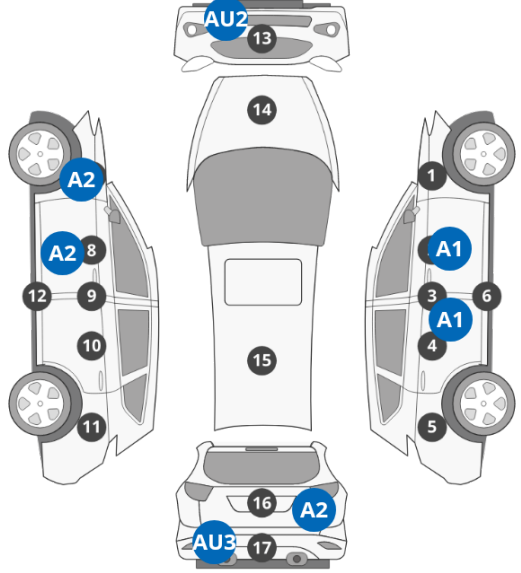
Interior Evaluation :	A	Exterior Evaluation :	B

<p>a : Cut, Fray d : Loose, Deformed k : Animal Hair s : Smell t : Cigarette Burns x : Defective y : Stain</p>		<p>A : Scratch AU : Scratch & Dent B : Modified C : Corrosion G : Stone chip P : Faded S : Rust SC : Rust & Corrosion U : Dent X : Defective Y : Crack, Gap</p>	
<p>Remarks Trunk Room - Worn, Scratch, Cut, Crack - Small</p>		<p>Remarks (R) Front Door, Molding - Scratch - Minimal / (R) Rear Door, Molding - Scratch - Minimal / Rear Bumper, Lamps, Panels - Scratch & Dent - Medium / Trunk Hood, Rear Gate - Scratch - Small / (L) Front Door, Molding - Scratch - Small / (L) Front Fender, Molding - Scratch - Small / Front Bumper, Grille, Lamps - Scratch & Dent - Small</p>	
Frame Evaluation :	A	Functional Evaluation :	A
<p>Remarks Defects not found</p>		<p>Remarks Spare Key - Issue - Unexist</p>
