General Information

Make	Toyota	Model	Vios
YOM	2025	Odo Meter Reading	21,906
Registration No.	NKJ2959	Chassis No.	PA1B18F33R4263485
CC	1.3	Transmission	CVT
Fuel Type	Gas	Type of Body	Sedan
Colour	Blue

Body / Panel Condition

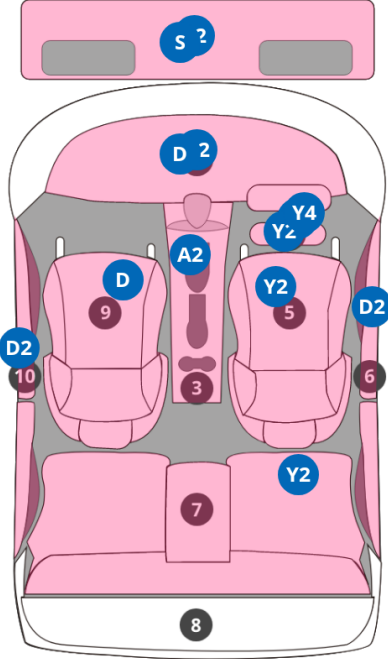
Interior Evaluation : C	Exterior Evaluation : E

<p>a : Cut, Fray d : Loose, Deformed k : Animal Hair s : Smell t : Cigarette Burns x : Defective y : Stain</p>

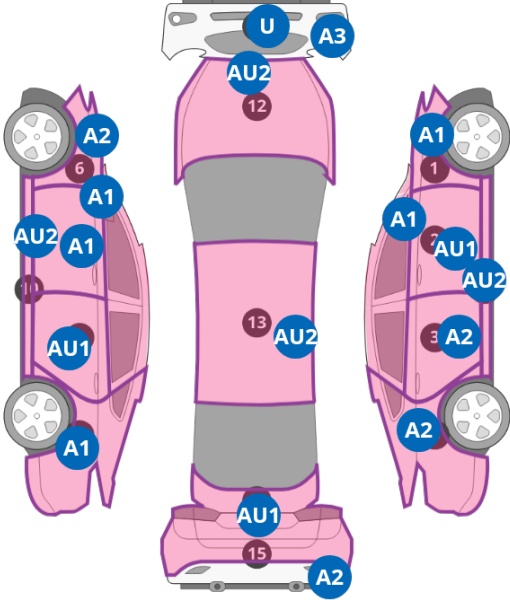
<p>A : Scratch AU : Scratch & Dent B : Modified C : Corrosion G : Stone chip P : Faded S : Rust SC : Rust & Corrosion U : Dent X : Defective Y : Crack, Gap</p>
<p>Remarks (L) Front Floor Mat - Worked - Small / (R) Front Floor Mat - Grime - Small / Mat Other - Grime - Large / Rear Seat - Grime - Small / (R) Front Seat - Grime - Small / (L) Front Seat - Worn - Yes / (L) Front Trim - Worked - Small / (R) Front Trim - Worked - Small / Dashboard - Worn, Scratch, Cut, Crack - Small / Dashboard - Traces of Adhesive Tape - Yes / Console, Switches, Vents - Worn, Scratch, Cut, Crack - Small / Ceiling - Grime - Small / Overall Interior - Smell - Yes</p>	<p>Remarks (R) Front Door - Repair Traces - Yes / (R) Step - Repair Traces - Yes / (R) Front Fender - Repair Traces - Yes / Bonnet - Repair Traces - Yes / (L) Front Fender - Repair Traces - Yes / (L) Front Door - Repair Traces - Yes / (L) Step - Repair Traces - Yes / (L) Rear Door - Repair Traces - Yes / (L) Rear Fender - Repair Traces - Yes / Trunk Hood, Rear Gate - Repair Traces - Yes / (L) Front Door, Molding - Repair mark - Yes / (L) Rear Fender, Molding - Repair mark - Yes / (L) Rear Door, Molding - Repair mark - Yes / (L) Step, In-panel, Side Spoiler - Repair mark - Yes / (L) Front Fender, Molding - Repair mark - Yes / (R) Front Fender, Molding - Repair mark - Yes / Bonnet, Headlight - Repair mark - Yes / Trunk Hood, Rear Gate - Repair mark - Yes / (R) Rear Fender, Molding - Repair mark - Yes / (R) Rear Door, Molding - Repair mark - Yes / (R) Front Door, Molding - Repair mark - Yes / Roof - Repair mark - Yes / Member (Bolted) - Dent - Yes / Front Bumper, Grille, Lamps - Scratch - Medium / (R) Front Fender, Molding - Scratch - Minimal / (R) Mirror - Scratch - Minimal / (R) Front Door, Molding - Scratch & Dent - Minimal / (R) Rear Door, Molding - Scratch - Small / (R) Step, In-panel, Side Spoiler - Scratch & Dent - Small / (R) Rear Fender, Molding - Scratch - Small / Trunk Hood, Rear Gate - Scratch & Dent - Minimal / Rear Bumper, Lamps, Panels - Scratch - Small / (L) Rear Fender, Molding - Scratch - Minimal / (L) Rear Door, Molding - Scratch & Dent - Minimal / (L) Step, In-panel, Side Spoiler - Scratch & Dent - Small / (L) Front Door, Molding - Scratch - Minimal / (L) Front Fender, Molding - Scratch - Small / Bonnet, Headlight - Scratch & Dent - Small / Roof - Scratch & Dent - Small / (L) Mirror - Scratch - Minimal</p>
