General Information

Make	Toyota	Model	Avanza
YOM	2024	Odo Meter Reading	26,033
Registration No.	NHM3630	Chassis No.	MHFAB1BY5P3075720
CC	1.5	Transmission	CVT
Fuel Type	Gas	Type of Body	MPV
Colour	Green

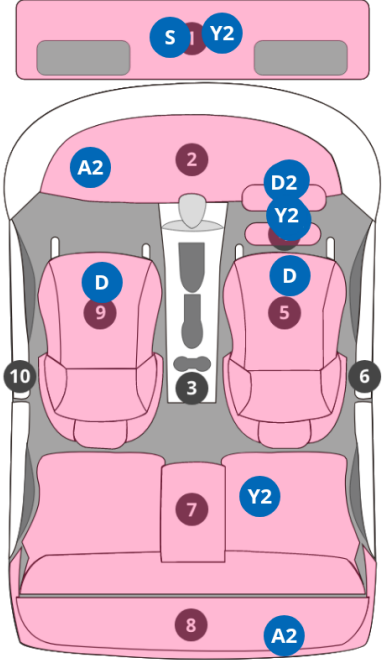
Interior Evaluation : C	Exterior Evaluation : D

<p>a : Cut, Fray d : Loose, Deformed k : Animal Hair s : Smell t : Cigarette Burns x : Defective y : Stain</p>

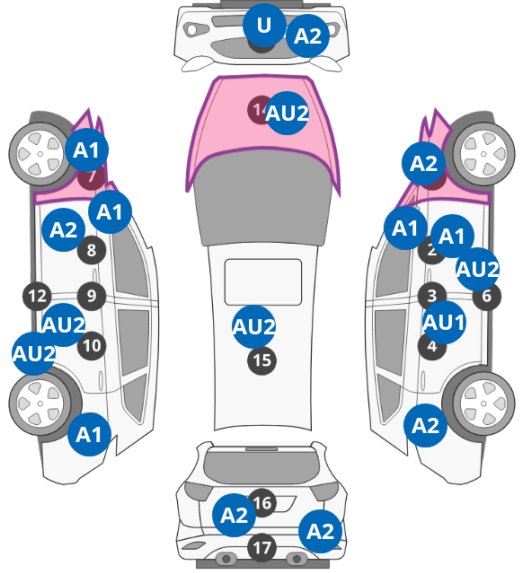
<p>A : Scratch AU : Scratch & Dent B : Modified C : Corrosion G : Stone chip P : Faded S : Rust SC : Rust & Corrosion U : Dent X : Defective Y : Crack, Gap</p>
<p>Remarks (L) Front Floor Mat - Worked - Small / Ceiling - Grime - Small / Dashboard - Worn, Scratch, Cut, Crack - Small / Glove Box - Loose, Deformed - Small / Steering Wheel - Worn, Peel, Crack - Small / Overall Interior - Smell - Yes / (L) Front Seat - Worn - Yes / (R) Front Seat - Worn - Yes / Rear Seat - Grime - Small / Mat Other - Grime - Small / Trunk Room - Worn, Scratch, Cut, Crack - Small</p>	<p>Remarks (R) Front Fender - Repair Traces - Yes / Bonnet - Repair Traces - Yes / (L) Front Fender - Repair Traces - Yes / (L) Front Fender, Molding - Repair mark - Yes / Bonnet, Headlight - Repair mark - Yes / (R) Front Fender, Molding - Repair mark - Yes / Bonnet, Headlight - Scratch & Dent - Small / (L) Front Fender, Molding - Scratch - Minimal / (L) Front Door, Molding - Scratch - Small / (L) Rear Door, Molding - Scratch & Dent - Small / (L) Rear Fender, Molding - Scratch - Minimal / (L) Step, In-panel, Side Spoiler - Scratch & Dent - Small / Member (Bolted) - Dent - Yes / Front Bumper, Grille, Lamps - Scratch - Small / Trunk Hood, Rear Gate - Scratch - Small / Rear Bumper, Lamps, Panels - Scratch - Small / (R) Rear Fender, Molding - Scratch - Small / (R) Rear Door, Molding - Scratch & Dent - Minimal / (R) Front Door, Molding - Scratch - Minimal / (R) Step, In-panel, Side Spoiler - Scratch & Dent - Small / (R) Front Fender, Molding - Scratch - Small / (R) Mirror - Scratch - Minimal / (L) Mirror - Scratch - Minimal / Roof - Scratch & Dent - Small</p>
