General Information

Make	Toyota	Model	RAV4
YOM	2018	Odo Meter Reading	66,997
Registration No.	GAG1192	Chassis No.	JTMZF9EV7HJ156539
CC	2.5	Transmission	A/T
Fuel Type	Gas	Type of Body	SUV
Colour	Gray

Body / Panel Condition

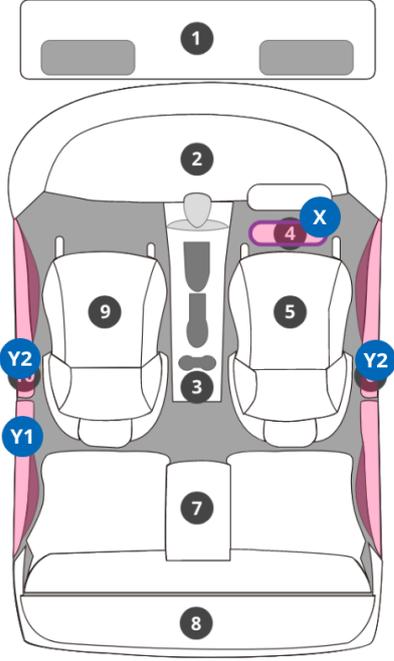
Interior Evaluation : B	Exterior Evaluation : C

<p>a : Cut, Fray d : Loose, Deformed k : Animal Hair s : Smell t : Cigarette Burns x : Defective y : Stain</p>

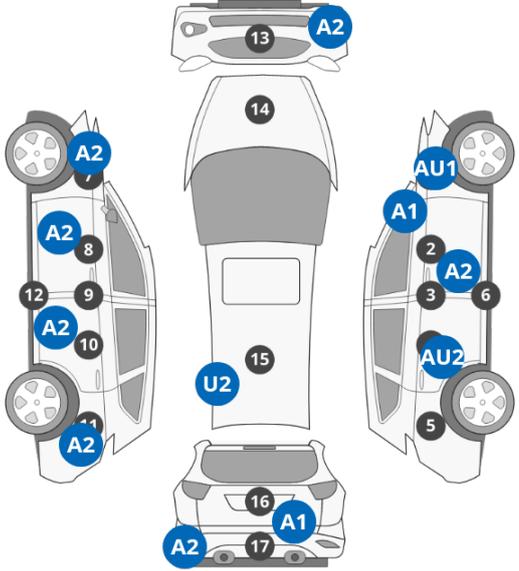
<p>A : Scratch AU : Scratch & Dent B : Modified C : Corrosion G : Stone chip P : Faded S : Rust SC : Rust & Corrosion U : Dent X : Defective Y : Crack, Gap</p>
<p>Remarks (R) Front Trim - Grime - Small / (L) Rear Trim - Grime - Minimal / (L) Front Trim - Grime - Small / (R) Front Floor Mat - Missing - Yes</p>	<p>Remarks (R) Rear Fender - Repair Traces - Yes / (R) Rear Door - Repair Traces - Yes / (R) Mirror - Scratch - Minimal / (R) Front Door, Molding - Scratch - Small / (R) Rear Door, Molding - Scratch & Dent - Small / (L) Rear Fender, Molding - Scratch - Small / (L) Rear Door, Molding - Scratch - Small / (L) Front Door, Molding - Scratch - Small / (L) Front Fender, Molding - Scratch - Small / Overall Exterior - Faded(Color, Gloss) - Yes / Front Bumper, Grille, Lamps - Scratch - Small / (R) Front Fender, Molding - Scratch & Dent - Minimal / Roof - Dent - Small / Rear Bumper, Lamps, Panels - Scratch - Small / Trunk Hood, Rear Gate - Scratch - Minimal</p>
