General Information

Make	Toyota	Model	Vios
YOM	2024	Odo Meter Reading	46,666
Registration No.	NHR8186	Chassis No.	PA1B18F37P4230731
CC	1.3	Transmission	M/T
Fuel Type	Gas	Type of Body	Sedan
Colour	Blue

Body / Panel Condition

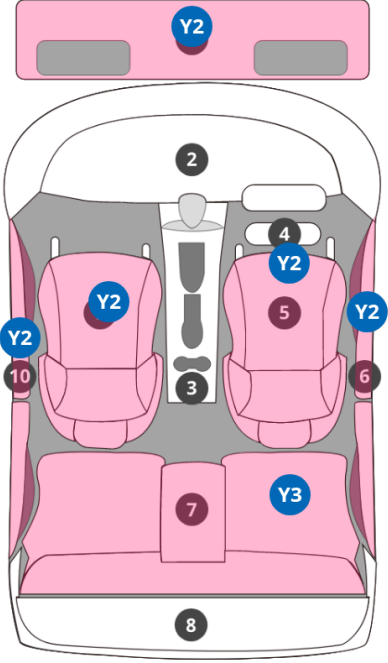
Interior Evaluation : B	Exterior Evaluation : D

<p>a : Cut, Fray d : Loose, Deformed k : Animal Hair s : Smell t : Cigarette Burns x : Defective y : Stain</p>

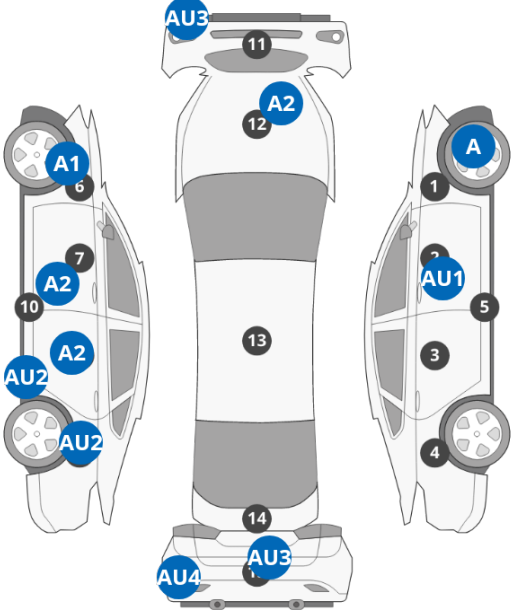
<p>A : Scratch AU : Scratch & Dent B : Modified C : Corrosion G : Stone chip P : Faded S : Rust SC : Rust & Corrosion U : Dent X : Defective Y : Crack, Gap</p>
<p>Remarks (R) Front Trim - Grime - Small / (R) Front Seat - Grime - Small / Rear Seat - Grime - Medium / (L) Front Seat - Grime - Small / (L) Front Trim - Grime - Small / Ceiling - Grime - Small</p>	<p>Remarks (R) Front Door - Repair Traces - Yes / (R) Rear Fender - Repair Traces - Yes / (R) Rear Door - Repair Traces - Yes / (R) Front Door, Molding - Scratch & Dent - Minimal / Trunk Hood, Rear Gate - Scratch & Dent - Medium / Rear Bumper, Lamps, Panels - Scratch & Dent - Large / (L) Rear Fender, Molding - Scratch & Dent - Small / (L) Step, In-panel, Side Spoiler - Scratch & Dent - Small / (L) Rear Door, Molding - Scratch - Small / (L) Front Door, Molding - Scratch - Small / (L) Front Fender, Molding - Scratch - Minimal / (R) Front Tyre - Crack, Cut - Yes / Bonnet, Headlight - Scratch - Small / Front Bumper, Grille, Lamps - Scratch & Dent - Medium</p>
