## General Information

| Make | Toyota | Model | Vios |

## Body / Panel Condition

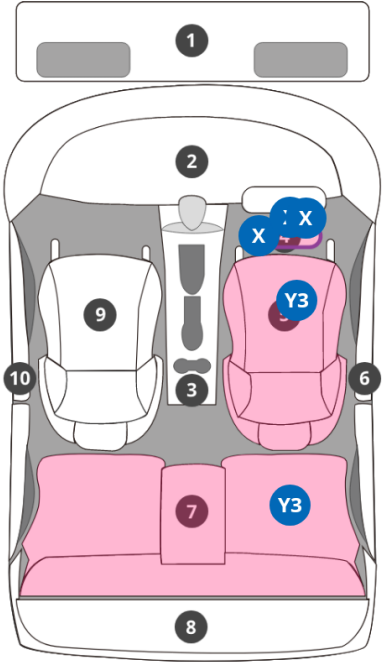
| Interior Evaluation : <b>B</b> | Exterior Evaluation : <b>B</b> |
|---|---|
| <p><b>Remarks</b><br/>(R) Front Floor Mat - Missing - Yes / (L) Front Floor Mat - Missing - Yes / Mat Other - Missing - Yes / Rear Seat - Grime - Medium / (R) Front Seat - Grime - Medium</p> | <p><b>Remarks</b><br/>Roof - Dent - Small / Trunk Hood, Rear Gate - Dent - Small / Front Bumper, Grille, Lamps - Dent - Medium / (R) Front Fender, Molding - Dent - Small</p> |
