General Information

Make	Lexus	Model	LS 460
YOM	2012	Odo Meter Reading	49,258
Registration No.	MSY08	Chassis No.	JTHGL46F305046559
CC	4.6	Transmission	A/T
Fuel Type	Gas	Type of Body	Sedan
Colour	Black

Body / Panel Condition

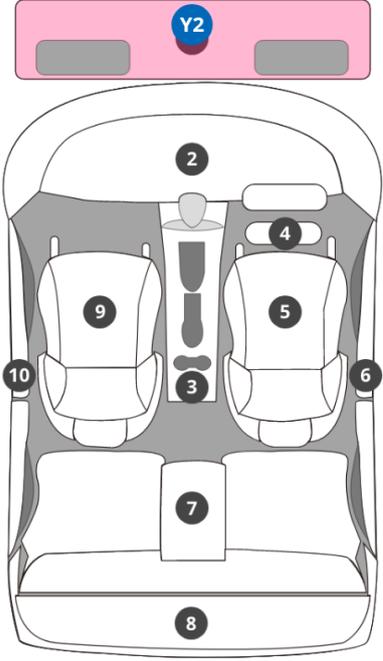
Interior Evaluation : A	Exterior Evaluation : B

<p>a : Cut, Fray d : Loose, Deformed k : Animal Hair s : Smell t : Cigarette Burns x : Defective y : Stain</p>

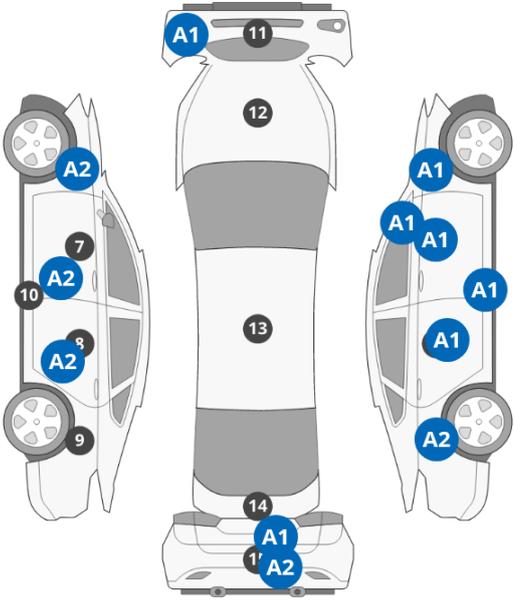
<p>A : Scratch AU : Scratch & Dent B : Modified C : Corrosion G : Stone chip P : Faded S : Rust SC : Rust & Corrosion U : Dent X : Defective Y : Crack, Gap</p>
Remarks Ceiling - Grime - Small	Remarks Bonnet - Repair Traces - Yes / (L) Rear Fender - Repair Traces - Yes / (R) Front Fender, Molding - Scratch - Minimal / (R) Front Door, Molding - Scratch - Minimal / (R) Step, In-panel, Side Spoiler - Scratch - Minimal / (R) Rear Door, Molding - Scratch - Minimal / (R) Rear Fender, Molding - Scratch - Small / Rear Bumper, Lamps, Panels - Scratch - Small / Trunk Hood, Rear Gate - Scratch - Minimal / (L) Front Door, Molding - Scratch - Small / (L) Rear Door, Molding - Scratch - Small / (L) Front Fender, Molding - Scratch - Small / (R) Mirror - Scratch - Minimal / Front Bumper, Grille, Lamps - Scratch - Minimal
