## General Information

| Make | Toyota | Model | Vios |
| Registration No. | ABJ6110 | Chassis No. | NCP1512043923 |

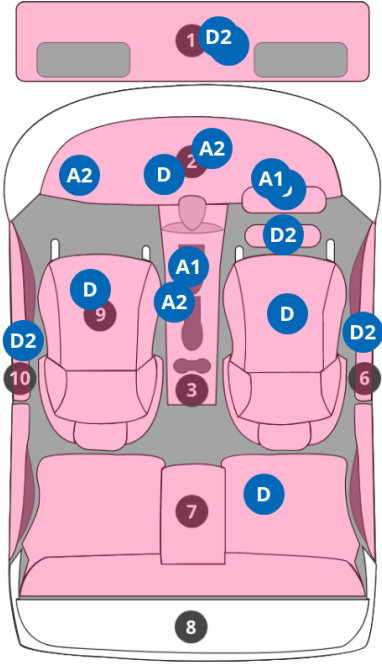
| Interior Evaluation : <span style="color: red;">D</span> | Exterior Evaluation : <span style="color: red;">E</span> |
|---|---|
| <b>Remarks</b><br>(L) Front Floor Mat - Worked - Small / Overall Interior - Smell - Yes / Overall Interior - Worn as per age - Yes / Dashboard - Worn, Scratch, Cut, Crack - Small / Dashboard - Traces of Adhesive Tape - Yes / Steering Wheel - Worn, Peel, Crack - Small / Glove Box - Traces of Adhesive Tape - Yes / Glove Box - Worn, Scratch, Cut, Crack - Minimal / (L) Front Seat - Worn - Yes / (R) Front Seat - Worn - Yes / (L) Front Trim - Worked - Small / (R) Front Trim - Worked - Small / Knobs - Worn, Peel, Crack - Small / Console, Switchs, Vents - Worn, Scratch, Cut, Crack - Minimal / Rear Seat - Worn - Yes / Ceiling - Crinkle - Small | <b>Remarks</b><br>(R) Front Door - Repair Traces - Yes / (R) Step - Repair Traces - Yes / (R) Front Fender - Repair Traces - Yes / Bonnet - Repair Traces - Yes / (L) Front Fender - Repair Traces - Yes / (L) Front Door - Repair Traces - Yes / (L) Step - Repair Traces - Yes / (L) Rear Door - Repair Traces - Yes / (L) Rear Fender - Repair Traces - Yes / Trunk Hood, Rear Gate - Repair Traces - Yes / (R) Rear Fender - Repair Traces - Yes / (R) Rear Door - Repair Traces - Yes / Roof - Repair Traces - Yes / (L) Rear Fender, Molding - Scratch & Dent - Medium / (L) Rear Fender, Molding - Repair mark - Yes / (L) Rear Door, Molding - Repair mark - Yes / (L) Front Door, Molding - Repair mark - Yes / (L) Front Fender, Molding - Repair mark - Yes / (L) Step, In-panel, Side Spoiler - Repair mark - Yes / (R) Step, In-panel, Side Spoiler - Repair mark - Yes / (R) Rear Fender, Molding - Repair mark - Yes / (R) Front Door, Molding - Repair mark - Yes / (R) Rear Door, Molding - Repair mark - Yes / (R) Front Fender, Molding - Repair mark - Yes / Trunk Hood, Rear Gate - Repair mark - Yes / Roof - Repair mark - Yes / Bonnet, Headlight - Repair mark - Yes / Member (Bolted) - Dent - Yes / (L) Front Door, Molding - Scratch & Dent - Medium / (L) Step, In-panel, Side Spoiler - Scratch & Dent - Small / (L) Rear Door, Molding - Scratch - Small / (L) Front Fender, Molding - Scratch & Dent - Minimal / (L) Mirror - Scratch - Minimal / Front Bumper, Grille, Lamps - Scratch - Large / Bonnet, Headlight - Scratch & Dent - Small / (R) Step, In-panel, Side Spoiler - Scratch & Dent - Large / (R) Front Door, Molding - Scratch & Dent - Small / (R) Rear Door, Molding - Scratch & Dent - Medium / (R) Rear Fender, Molding - Scratch & Dent - Large / Rear Bumper, Lamps, Panels - Scratch - Large / Trunk Hood, Rear Gate - Scratch & Dent - Small / Trunk Hood, Rear Gate - Modified - Medium / Overall Exterior - Faded(Color, Gloss) - Yes / Roof - Scratch & Dent - Small / (R) Front Fender, Molding - Scratch & Dent - Small / (R) Mirror - Scratch - Minimal |
