General Information

Make	Toyota	Model	Vios
YOM	2024	Odo Meter Reading	59,886
Registration No.	DBO7497	Chassis No.	PA1B18F31R4252422
CC	1.3	Transmission	CVT
Fuel Type	Gas	Type of Body	Sedan
Colour	Red Mica Metallic

Body / Panel Condition

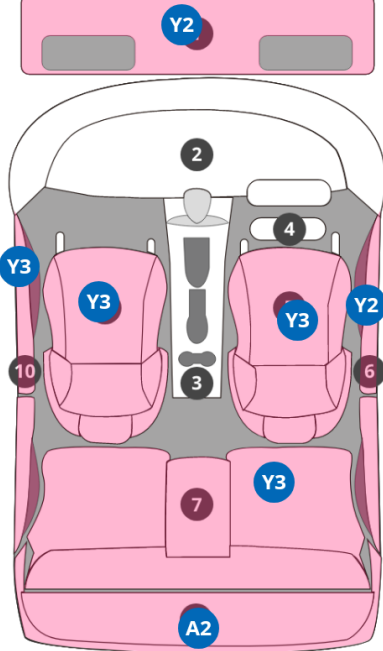
Interior Evaluation : C	Exterior Evaluation : E

<p>a : Cut, Fray d : Loose, Deformed k : Animal Hair s : Smell t : Cigarette Burns x : Defective y : Stain</p>

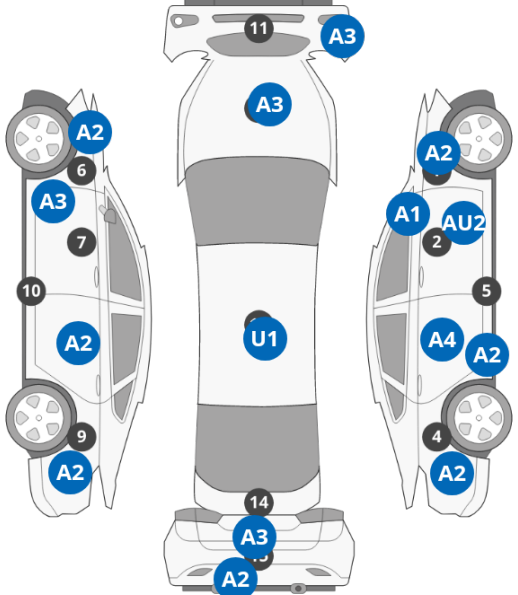
<p>A : Scratch AU : Scratch & Dent B : Modified C : Corrosion G : Stone chip P : Faded S : Rust SC : Rust & Corrosion U : Dent X : Defective Y : Crack, Gap</p>
<p>Remarks Trunk Room - Worn, Scratch, Cut, Crack - Small / Rear Seat - Grime - Medium / (R) Front Trim - Grime - Small / (R) Front Seat - Grime - Medium / (L) Front Trim - Grime - Medium / (L) Front Seat - Grime - Medium / Ceiling - Grime - Small</p>	<p>Remarks Roof - Dent - Minimal / (R) Front Door, Molding - Scratch & Dent - Small / (R) Mirror - Scratch - Minimal / (R) Front Fender, Molding - Scratch - Small / Bonnet, Headlight - Scratch - Medium / (R) Step, In-panel, Side Spoiler - Scratch - Small / (R) Rear Door, Molding - Scratch - Large / (R) Rear Fender, Molding - Scratch - Small / Trunk Hood, Rear Gate - Scratch - Medium / Rear Bumper, Lamps, Panels - Scratch - Small / (L) Rear Fender, Molding - Scratch - Small / (L) Rear Door, Molding - Scratch - Small / (L) Front Door, Molding - Scratch - Medium / (L) Front Fender, Molding - Scratch - Small / Front Bumper, Grille, Lamps - Scratch - Medium</p>
