## General Information

<b>Make</b>	Mitsubishi	<b>Model</b>	Mirage
<b>YOM</b>	2024	<b>Odo Meter Reading</b>	23,922
<b>Registration No.</b>	NHR9916	<b>Chassis No.</b>	PAEA13TJRPA017676
<b>CC</b>	1.2	<b>Transmission</b>	CVT
<b>Fuel Type</b>	Gas	<b>Type of Body</b>	Sedan
<b>Colour</b>	Gray

## Body / Panel Condition

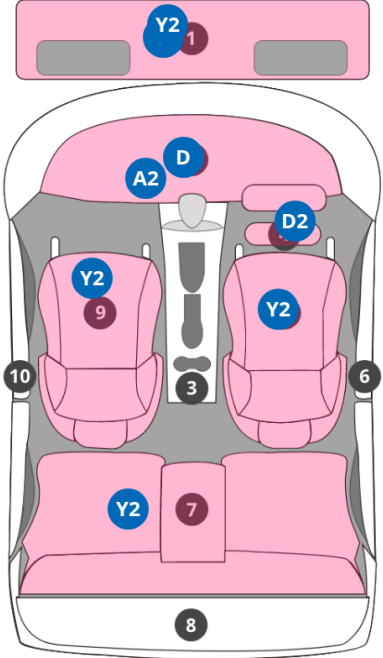
<b>Interior Evaluation :</b> <span style="float: right;"><b>B</b></span>	<b>Exterior Evaluation :</b> <span style="float: right;"><b>C</b></span>

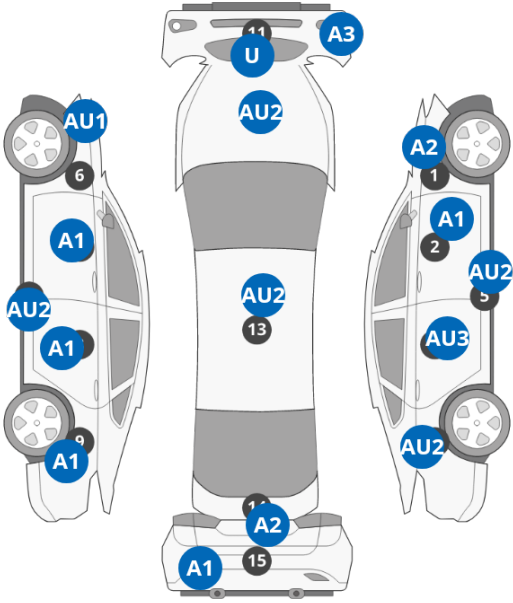
<p><b>A</b> : Scratch <b>AU</b> : Scratch &amp; Dent <b>B</b> : Modified <b>C</b> : Corrosion <b>G</b> : Stone chip <b>P</b> : Faded <b>S</b> : Rust <b>SC</b> : Rust &amp; Corrosion <b>U</b> : Dent <b>X</b> : Defective <b>Y</b> : Crack, Gap</p>
<p><b>Remarks</b> (L) Front Floor Mat - Worked - Small / (L) Front Seat - Grime - Small / (R) Front Seat - Grime - Small / Rear Seat - Grime - Small / Dashboard - Traces of Adhesive Tape - Yes / Dashboard - Worn, Scratch, Cut, Crack - Small / Overall Interior - Smell - Yes / Ceiling - Grime - Small</p>	<p><b>Remarks</b> (L) Rear Fender, Molding - Scratch - Minimal / (L) Rear Door, Molding - Scratch - Minimal / (L) Front Door, Molding - Scratch - Minimal / (L) Front Fender, Molding - Scratch &amp; Dent - Minimal / Front Bumper, Grille, Lamps - Scratch - Medium / (L) Step, In-panel, Side Spoiler - Scratch &amp; Dent - Small / (R) Front Fender, Molding - Scratch - Small / (R) Front Door, Molding - Scratch - Minimal / (R) Rear Door, Molding - Scratch &amp; Dent - Medium / (R) Rear Fender, Molding - Scratch &amp; Dent - Small / Trunk Hood, Rear Gate - Scratch - Small / Bonnet, Headlight - Scratch &amp; Dent - Small / Member (Bolted) - Dent - Yes / Rear Bumper, Lamps, Panels - Scratch - Minimal / Roof - Scratch &amp; Dent - Small / (R) Step, In-panel, Side Spoiler - Scratch &amp; Dent - Small</p>
