General Information

Make	Toyota	Model	Vios
YOM	2025	Odo Meter Reading	25,139
Registration No.	NHS5039	Chassis No.	PA1B18F35R4264119
CC	1.3	Transmission	CVT
Fuel Type	Gas	Type of Body	Sedan
Colour	Silver

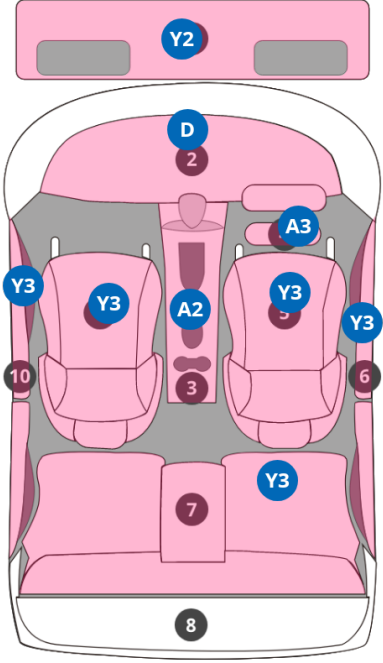
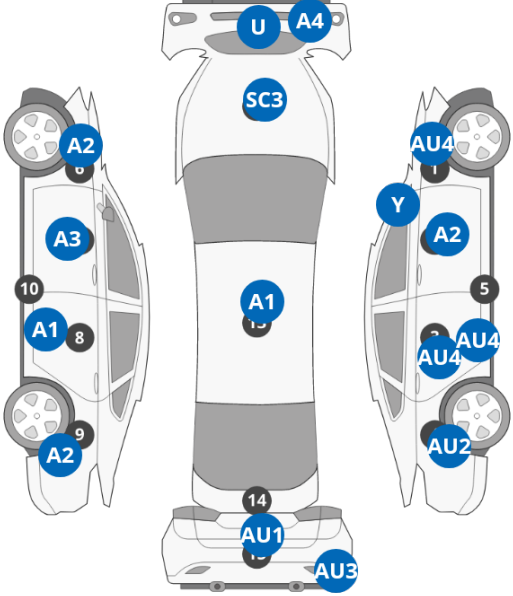
Interior Evaluation :	C	Exterior Evaluation :	E

<p>a : Cut, Fray d : Loose, Deformed k : Animal Hair s : Smell t : Cigarette Burns x : Defective y : Stain</p>		<p>A : Scratch AU : Scratch & Dent B : Modified C : Corrosion G : Stone chip P : Faded S : Rust SC : Rust & Corrosion U : Dent X : Defective Y : Crack, Gap</p>	
<p>Remarks Rear Seat - Grime - Medium / (R) Front Seat - Grime - Medium / (R) Front Trim - Grime - Medium / (L) Front Trim - Grime - Medium / (L) Front Seat - Grime - Medium / (L) Front Floor Mat - Cut, Crack - Medium / Ceiling - Grime - Small / Dashboard - Traces of Adhesive Tape - Yes / Console, Switchs, Vents - Worn, Scratch, Cut, Crack - Small</p>		<p>Remarks (R) Front Fender, Molding - Scratch & Dent - Large / Front Bumper, Grille, Lamps - Scratch - Large / Member (Bolted) - Dent - Yes / (R) Mirror - Crack - Damaged / (R) Front Door, Molding - Scratch - Small / (R) Rear Door, Molding - Scratch & Dent - Large / (R) Step, In-panel, Side Spoiler - Scratch & Dent - Large / (R) Rear Fender, Molding - Scratch & Dent - Small / Rear Bumper, Lamps, Panels - Scratch & Dent - Medium / (L) Rear Fender, Molding - Scratch - Small / (L) Rear Door, Molding - Scratch - Minimal / (L) Front Door, Molding - Scratch - Medium / (L) Front Fender, Molding - Scratch - Small / Bonnet, Headlight - Rust, Corrosion - Medium / Trunk Hood, Rear Gate - Scratch & Dent - Minimal / Roof - Scratch - Minimal</p>
