General Information

Make	Toyota	Model	Vios
YOM	2017	Odo Meter Reading	82,604
Registration No.	NAR5687	Chassis No.	PA1B19F34H4029411
CC	1.3	Transmission	A/T
Fuel Type	Gas	Type of Body	Sedan
Colour	Silver

Body / Panel Condition

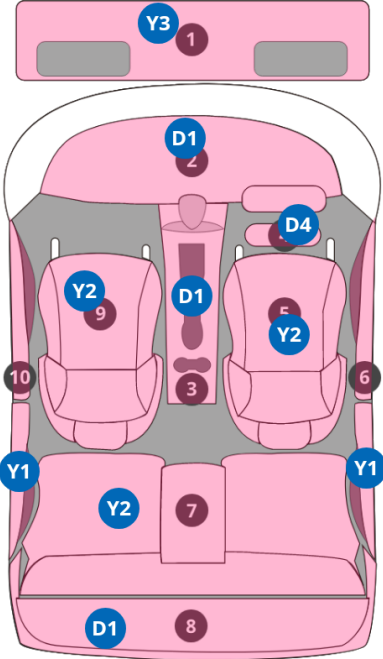
Interior Evaluation : C	Exterior Evaluation : E

<p>a : Cut, Fray d : Loose, Deformed k : Animal Hair s : Smell t : Cigarette Burns x : Defective y : Stain</p>

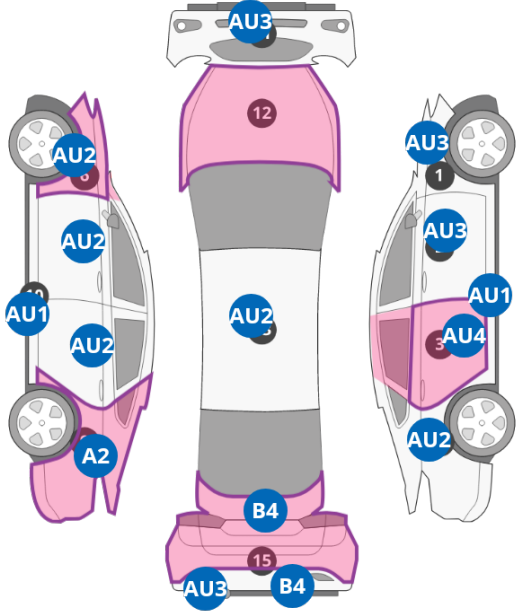
<p>A : Scratch AU : Scratch & Dent B : Modified C : Corrosion G : Stone chip P : Faded S : Rust SC : Rust & Corrosion U : Dent X : Defective Y : Crack, Gap</p>
<p>Remarks Ceiling - Grime - Medium / (L) Front Seat - Grime - Small / (R) Front Seat - Grime - Small / (L) Front Floor Mat - Worked - Large / Rear Seat - Grime - Small / Trunk Room - Worked - Minimal / Dashboard - Worked - Minimal / Console, Switches, Vents - Worked - Minimal / (L) Rear Trim - Grime - Minimal / (R) Rear Trim - Grime - Minimal</p>	<p>Remarks (R) Step - Repair Traces - Yes / (R) Front Fender - Repair Traces - Yes / Bonnet - Repair Traces - Yes / (L) Front Fender - Repair Traces - Yes / (L) Front Door - Repair Traces - Yes / Trunk Hood, Rear Gate - Repair Traces - Yes / (R) Rear Fender - Repair Traces - Yes / (R) Rear Door - Repair Traces - Yes / (L) Front Fender, Molding - Repair mark - Yes / (L) Front Fender, Molding - Scratch & Dent - Small / Bonnet, Headlight - Repair mark - Yes / Front Bumper, Grille, Lamps - Scratch & Dent - Medium / (R) Front Fender, Molding - Scratch & Dent - Medium / (R) Front Door, Molding - Scratch & Dent - Medium / (R) Rear Door, Molding - Scratch & Dent - Large / (R) Rear Door, Molding - Repair mark - Yes / Roof - Scratch & Dent - Small / Overall Exterior - Worn as per age - Yes / (R) Rear Fender, Molding - Scratch & Dent - Small / Rear Bumper, Lamps, Panels - Modified - Large / Rear Bumper, Lamps, Panels - Scratch & Dent - Medium / Trunk Hood, Rear Gate - Repair mark - Yes / Trunk Hood, Rear Gate - Modified - Large / (L) Rear Fender, Molding - Scratch - Small / (L) Rear Fender, Molding - Repair mark - Yes / (L) Rear Door, Molding - Scratch & Dent - Small / (L) Front Door, Molding - Scratch & Dent - Small / (L) Step, In-panel, Side Spoiler - Scratch & Dent - Minimal / (R) Step, In-panel, Side Spoiler - Scratch & Dent - Minimal</p>
