General Information

Make	Toyota	Model	Vios
YOM	2025	Odo Meter Reading	21,898
Registration No.	DBU3843	Chassis No.	PA1B18F32S4287458
CC	1.3	Transmission	CVT
Fuel Type	Gas	Type of Body	Sedan
Colour	Red Mica Metallic

Body / Panel Condition

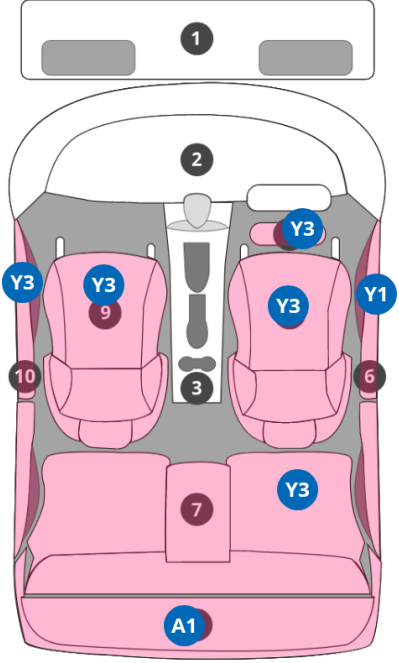
Interior Evaluation : C	Exterior Evaluation : C

<p>a : Cut, Fray d : Loose, Deformed k : Animal Hair s : Smell t : Cigarette Burns x : Defective y : Stain</p>

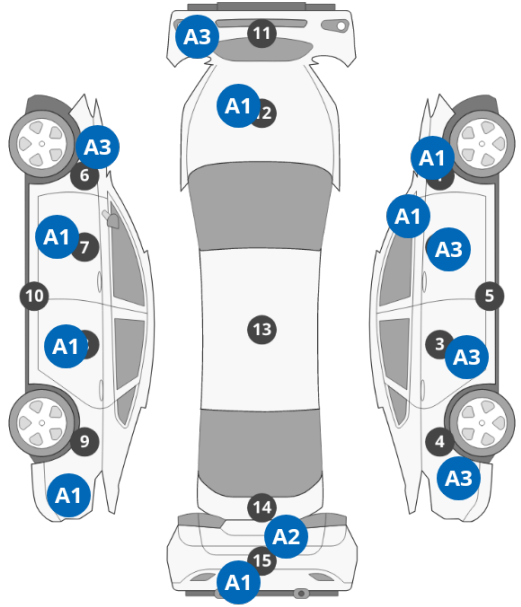
<p>A : Scratch AU : Scratch & Dent B : Modified C : Corrosion G : Stone chip P : Faded S : Rust SC : Rust & Corrosion U : Dent X : Defective Y : Crack, Gap</p>
<p>Remarks (R) Front Trim - Grime - Minimal / (R) Front Seat - Grime - Medium / Rear Seat - Grime - Medium / Trunk Room - Worn, Scratch, Cut, Crack - Minimal / (L) Front Trim - Grime - Medium / (L) Front Floor Mat - Grime - Medium / (L) Front Seat - Grime - Medium</p>	<p>Remarks Trunk Hood, Rear Gate - Scratch - Small / (R) Rear Fender, Molding - Scratch - Medium / Rear Bumper, Lamps, Panels - Scratch - Minimal / (R) Rear Door, Molding - Scratch - Medium / (R) Front Door, Molding - Scratch - Medium / (R) Mirror - Scratch - Minimal / Front Bumper, Grille, Lamps - Scratch - Medium / (L) Front Fender, Molding - Scratch - Medium / (L) Front Door, Molding - Scratch - Minimal / (L) Rear Fender, Molding - Scratch - Minimal / Bonnet, Headlight - Scratch - Minimal / (L) Rear Door, Molding - Scratch - Minimal / (R) Front Fender, Molding - Scratch - Minimal</p>
