## General Information

<b>Make</b>	Toyota	<b>Model</b>	Lite Ace
<b>YOM</b>	2022	<b>Odo Meter Reading</b>	150,462
<b>Registration No.</b>	NFO7652	<b>Chassis No.</b>	MHKU3FE10NK000413
<b>CC</b>	1.5	<b>Transmission</b>	M/T
<b>Fuel Type</b>	Gas	<b>Type of Body</b>	Commercial Vehicles
<b>Colour</b>	White

## Body / Panel Condition

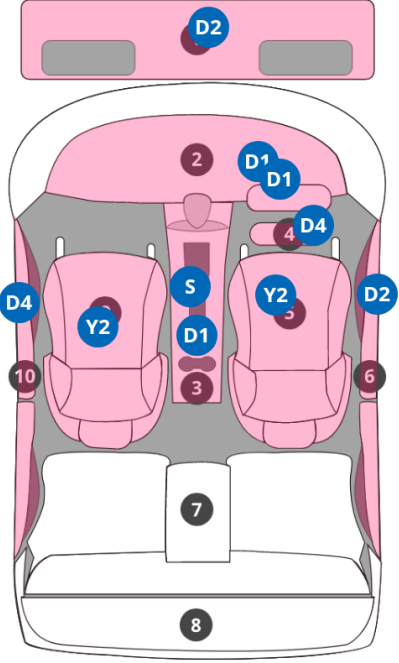
<b>Interior Evaluation :</b> <span style="float: right; color: red; font-weight: bold;">C</span>	<b>Exterior Evaluation :</b> <span style="float: right; color: red; font-weight: bold;">E</span>

<p><b>a</b> : Cut, Fray <b>d</b> : Loose, Deformed <b>k</b> : Animal Hair <b>s</b> : Smell <b>t</b> : Cigarette Burns <b>x</b> : Defective <b>y</b> : Stain</p>

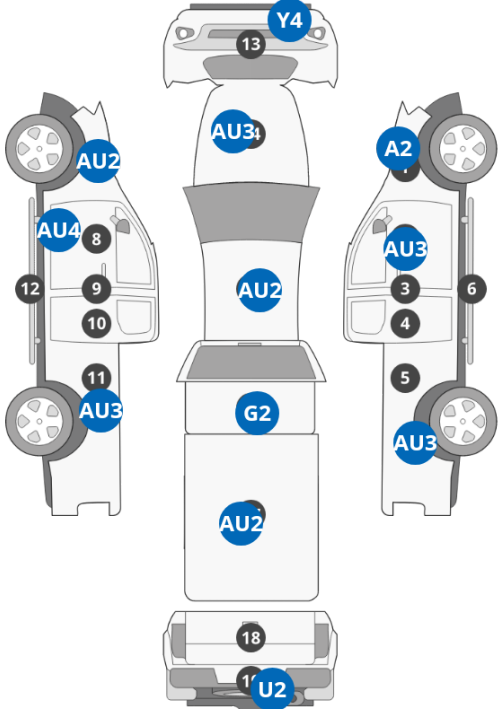
<p><b>A</b> : Scratch <b>AU</b> : Scratch &amp; Dent <b>B</b> : Modified <b>C</b> : Corrosion <b>G</b> : Stone chip <b>P</b> : Faded <b>S</b> : Rust <b>SC</b> : Rust &amp; Corrosion <b>U</b> : Dent <b>X</b> : Defective <b>Y</b> : Crack, Gap</p>
<p><b>Remarks</b> Ceiling - Crinkle - Small / (L) Front Trim - Worked - Large / (R) Front Trim - Worked - Small / Mat Other - Worked - Large / (L) Front Seat - Grime - Small / (R) Front Seat - Grime - Small / Dashboard - Worked - Minimal / Console, Switches, Vents - Worked - Minimal / Overall Interior - Smell - Yes / Instrument Panel - Worked - Minimal</p>	<p><b>Remarks</b> (R) Front Fender - Repair Traces - Yes / Bonnet - Repair Traces - Yes / (L) Front Fender - Repair Traces - Yes / (L) Front Door - Repair Traces - Yes / (L) Rear Corner Panel - Repair Traces - Yes / Roof - Repair Traces - Yes / Overall Exterior - Full Re-Paint in same color - Yes / (L) Front Door, Molding - Scratch &amp; Dent - Large / Bonnet, Headlight - Scratch &amp; Dent - Medium / (R) Front Fender, Molding - Scratch - Small / (R) Front Door, Molding - Scratch &amp; Dent - Medium / Roof - Scratch &amp; Dent - Small / Front Bumper, Grille, Lamps - Crack, Gap - Large / (L) Guard Frame - Scratch &amp; Dent - Medium / Rear Bumper, Lamps, Panels - Dent - Small / (R) Guard Frame - Scratch &amp; Dent - Medium / Cab Back Panel - Scratch &amp; Dent - Small / Rear Windshield - Scratch, Stone chip - Small / (L) Front Fender, Molding - Scratch &amp; Dent - Small</p>
