General Information

Make	Toyota	Model	Wigo
YOM	2022	Odo Meter Reading	24,874
Registration No.	DAQ5810 - NON-MOVING	Chassis No.	MHKA4DF5FNJ068205
CC	1.0	Transmission	A/T
Fuel Type	Gas	Type of Body	Hatchback
Colour	White

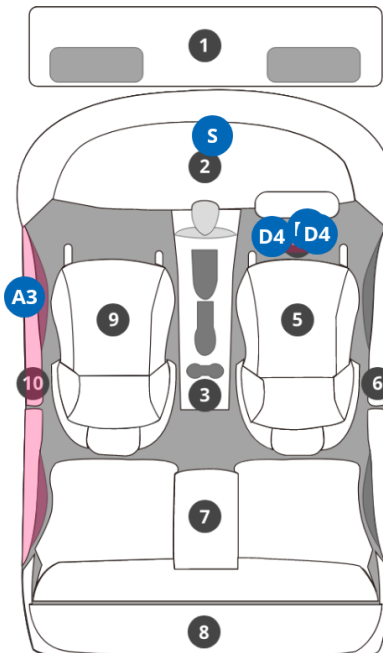
Interior Evaluation : C	Exterior Evaluation : E

<p>a : Cut, Fray d : Loose, Deformed k : Animal Hair s : Smell t : Cigarette Burns x : Defective y : Stain</p>

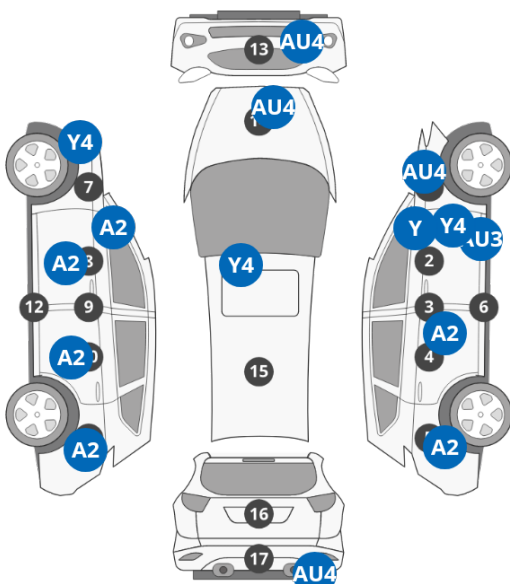
<p>A : Scratch AU : Scratch & Dent B : Modified C : Corrosion G : Stone chip P : Faded S : Rust SC : Rust & Corrosion U : Dent X : Defective Y : Crack, Gap</p>
<p>Remarks (L) Front Floor Mat - Worked - Large / (L) Front Trim - Cut, Crack - Medium / Overall Interior - Smell - Yes / Overall Interior - Worn as per age - Yes / Mat Other - Worked - Large / (R) Front Floor Mat - Worked - Large</p>	<p>Remarks Front Bumper, Grille, Lamps - Scratch & Dent - Large / Bonnet, Headlight - Scratch & Dent - Large / (R) Front Fender, Molding - Scratch & Dent - Large / (R) Step, In-panel, Side Spoiler - Scratch & Dent - Medium / (R) Front Door, Molding - Crack, Gap - Large / (R) Mirror - Crack - Damaged / Front Windshield - Damaged - Large / (L) Front Fender, Molding - Crack, Gap - Large / (L) Mirror - Scratch - Small / Rear Bumper, Lamps, Panels - Scratch & Dent - Large / (R) Rear Door, Molding - Scratch - Small / (R) Rear Fender, Molding - Scratch - Small / (L) Rear Fender, Molding - Scratch - Small / (L) Rear Door, Molding - Scratch - Small / (L) Front Door, Molding - Scratch - Small</p>
