General Information

Make	Toyota	Model	Rush
YOM	2024	Odo Meter Reading	45,990
Registration No.	DBO6782	Chassis No.	MHKE8FF3PRK060258
CC	1.5	Transmission	A/T
Fuel Type	Gas	Type of Body	SUV
Colour	White

Body / Panel Condition

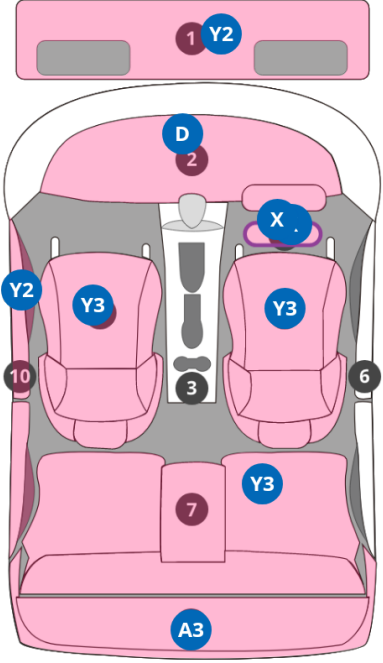
Interior Evaluation : C	Exterior Evaluation : D

<p>a : Cut, Fray d : Loose, Deformed k : Animal Hair s : Smell t : Cigarette Burns x : Defective y : Stain</p>

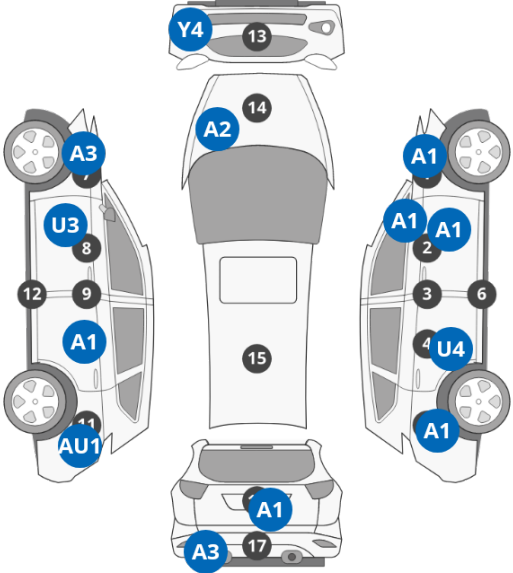
<p>A : Scratch AU : Scratch & Dent B : Modified C : Corrosion G : Stone chip P : Faded S : Rust SC : Rust & Corrosion U : Dent X : Defective Y : Crack, Gap</p>
<p>Remarks (R) Front Floor Mat - Missing - Yes / (R) Front Seat - Grime - Medium / Rear Seat - Grime - Medium / Mat Other - Missing - Yes / Trunk Room - Worn, Scratch, Cut, Crack - Medium / (L) Front Trim - Grime - Small / (L) Front Seat - Grime - Medium / Ceiling - Grime - Small / Dashboard - Traces of Adhesive Tape - Yes</p>	<p>Remarks Rear Bumper, Lamps, Panels - Scratch - Medium / (L) Rear Fender, Molding - Scratch & Dent - Minimal / (L) Front Door, Molding - Dent - Medium / (L) Front Fender, Molding - Scratch - Medium / Front Bumper, Grille, Lamps - Crack, Gap - Large / Bonnet, Headlight - Scratch - Small / (R) Mirror - Scratch - Minimal / (R) Front Fender, Molding - Scratch - Minimal / (R) Front Door, Molding - Scratch - Minimal / (R) Rear Door, Molding - Dent - Large / (R) Rear Fender, Molding - Scratch - Minimal / Trunk Hood, Rear Gate - Scratch - Minimal / (L) Rear Door, Molding - Scratch - Minimal</p>
