General Information

Make	Toyota	Model	Camry
YOM	2022	Odo Meter Reading	63,013
Registration No.	NFE1522	Chassis No.	MR2B53HK1N4012832
CC	2.5	Transmission	CVT
Fuel Type	Gas	Type of Body	Sedan
Colour	Black

Body / Panel Condition

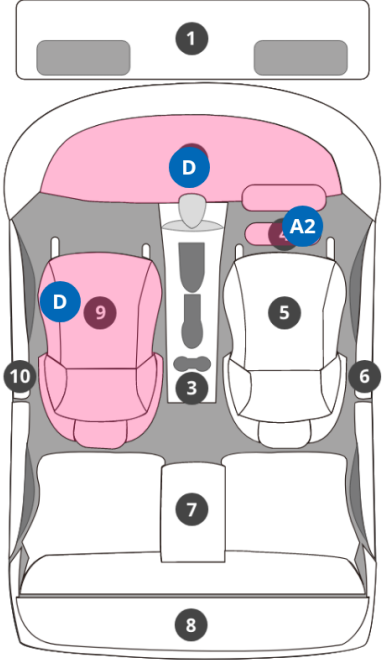
Interior Evaluation : B	Exterior Evaluation : D

<p>a : Cut, Fray d : Loose, Deformed k : Animal Hair s : Smell t : Cigarette Burns x : Defective y : Stain</p>

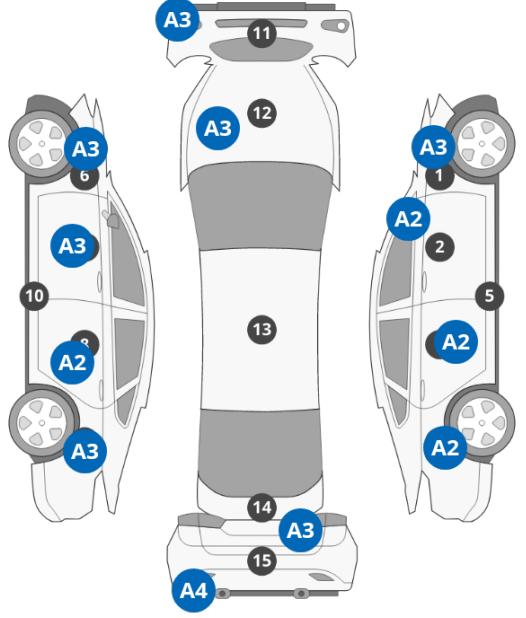
<p>A : Scratch AU : Scratch & Dent B : Modified C : Corrosion G : Stone chip P : Faded S : Rust SC : Rust & Corrosion U : Dent X : Defective Y : Crack, Gap</p>
Remarks Mat Other - Cut, Crack - Small / (L) Front Seat - Worn - Yes / Dashboard - Traces of Adhesive Tape - Yes	Remarks Front Bumper, Grille, Lamps - Scratch - Medium / (L) Front Fender, Molding - Scratch - Medium / Bonnet, Headlight - Scratch - Medium / (L) Front Door, Molding - Scratch - Medium / (L) Rear Fender, Molding - Scratch - Medium / Rear Bumper, Lamps, Panels - Scratch - Large / Trunk Hood, Rear Gate - Scratch - Medium / (R) Front Fender, Molding - Scratch - Medium
Frame Evaluation : A	Functional Evaluation : C
Remarks Defects not found	Remarks Power Window (each) - Stuck, Gap - Yes / Battery - Weak - Yes
