General Information

Make	Toyota	Model	Vios
YOM	2022	Odo Meter Reading	37,435
Registration No.	NFH9352	Chassis No.	PA1B18F34N4177774
CC	1.3	Transmission	CVT
Fuel Type	Gas	Type of Body	Sedan
Colour	Black

Body / Panel Condition

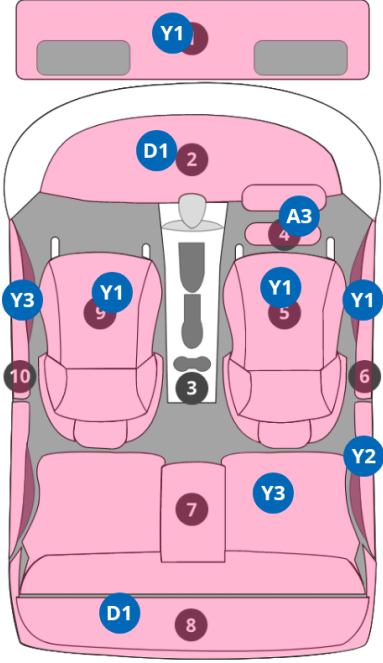
Interior Evaluation : B	Exterior Evaluation : E

<p>a : Cut, Fray d : Loose, Deformed k : Animal Hair s : Smell t : Cigarette Burns x : Defective y : Stain</p>

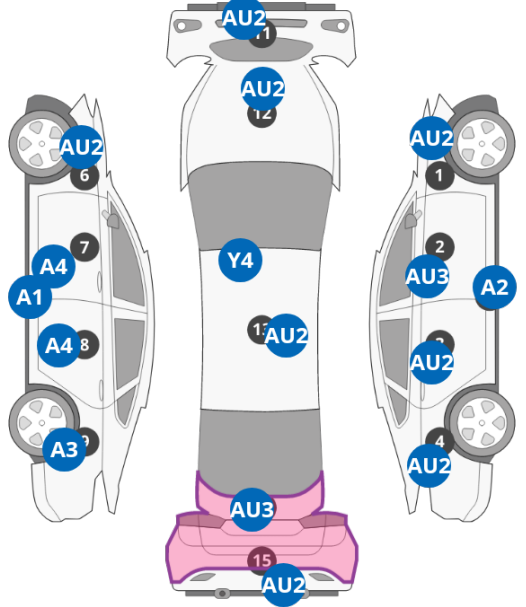
<p>A : Scratch AU : Scratch & Dent B : Modified C : Corrosion G : Stone chip P : Faded S : Rust SC : Rust & Corrosion U : Dent X : Defective Y : Crack, Gap</p>
<p>Remarks Ceiling - Grime - Minimal / (R) Front Seat - Grime - Minimal / (L) Front Seat - Grime - Minimal / Rear Seat - Grime - Medium / (L) Front Trim - Grime - Medium / (R) Front Trim - Grime - Minimal / (R) Rear Trim - Grime - Small / Dashboard - Worked - Minimal / Trunk Room - Worked - Minimal / (L) Front Floor Mat - Cut, Crack - Medium</p>	<p>Remarks Trunk Hood, Rear Gate - Repair Traces - Yes / Front Windshield - Damaged - Large / (L) Rear Door, Molding - Scratch - Large / (L) Front Door, Molding - Scratch - Large / (L) Rear Fender, Molding - Scratch - Medium / Trunk Hood, Rear Gate - Scratch & Dent - Medium / Trunk Hood, Rear Gate - Repair mark - Yes / Roof - Scratch & Dent - Small / (R) Rear Door, Molding - Scratch & Dent - Small / (R) Front Door, Molding - Scratch & Dent - Medium / (R) Front Fender, Molding - Scratch & Dent - Small / Front Bumper, Grille, Lamps - Scratch & Dent - Small / Bonnet, Headlight - Scratch & Dent - Small / (L) Front Fender, Molding - Scratch & Dent - Small / (L) Step, In-panel, Side Spoiler - Scratch - Minimal / (R) Step, In-panel, Side Spoiler - Scratch - Small / (R) Rear Fender, Molding - Scratch & Dent - Small / Rear Bumper, Lamps, Panels - Scratch & Dent - Small</p>
