General Information

Make	Toyota	Model	Vios
YOM	2022	Odo Meter Reading	43,805
Registration No.	NGQ3573	Chassis No.	PA1B18F32N4178325
CC	1.3	Transmission	CVT
Fuel Type	Gas	Type of Body	Sedan
Colour	Black

Body / Panel Condition

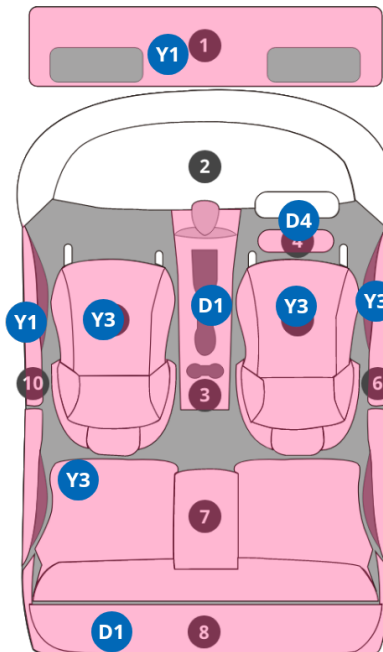
Interior Evaluation : C	Exterior Evaluation : D

<p>a : Cut, Fray d : Loose, Deformed k : Animal Hair s : Smell t : Cigarette Burns x : Defective y : Stain</p>

<p>A : Scratch AU : Scratch & Dent B : Modified C : Corrosion G : Stone chip P : Faded S : Rust SC : Rust & Corrosion U : Dent X : Defective Y : Crack, Gap</p>
<p>Remarks (L) Front Floor Mat - Worked - Large / (R) Front Seat - Grime - Medium / (L) Front Seat - Grime - Medium / (R) Front Trim - Grime - Medium / Rear Seat - Grime - Medium / Ceiling - Grime - Minimal / Console, Switches, Vents - Worked - Minimal / (L) Front Trim - Grime - Minimal / Trunk Room - Worked - Minimal</p>	<p>Remarks (R) Rear Door, Molding - Scratch & Dent - Small / (R) Step, In-panel, Side Spoiler - Scratch & Dent - Small / (R) Rear Fender, Molding - Scratch & Dent - Small / Rear Bumper, Lamps, Panels - Dent - Small / Trunk Hood, Rear Gate - Scratch & Dent - Small / (L) Rear Fender, Molding - Scratch - Medium / (L) Rear Door, Molding - Scratch - Medium / (L) Front Door, Molding - Scratch - Medium / (L) Front Fender, Molding - Scratch & Dent - Small / Bonnet, Headlight - Scratch & Dent - Small / Front Bumper, Grille, Lamps - Scratch & Dent - Small / (R) Front Fender, Molding - Scratch & Dent - Small / (R) Front Door, Molding - Rust, Corrosion - Minimal / Roof - Scratch & Dent - Minimal / (L) Step, In-panel, Side Spoiler - Scratch & Dent - Small</p>

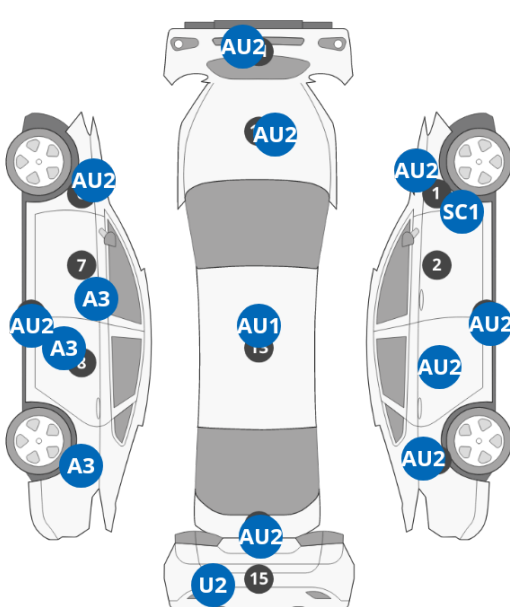
<p>Inspector Notes</p>
<p>with LTO plate, with spare tire, with spare key, with incomplete tools & jack, with warranty & manual booklet, no reverse camera, issue on foglamps, issue on brake & plate light, scratches on Taillight.</p>
