General Information

Make	Toyota	Model	Lite Ace
YOM	2024	Odo Meter Reading	24,267
Registration No.	DBO5864	Chassis No.	MHKU3FE10RK007391
CC	1.5	Transmission	M/T
Fuel Type	Gas	Type of Body	Dropside
Colour	White

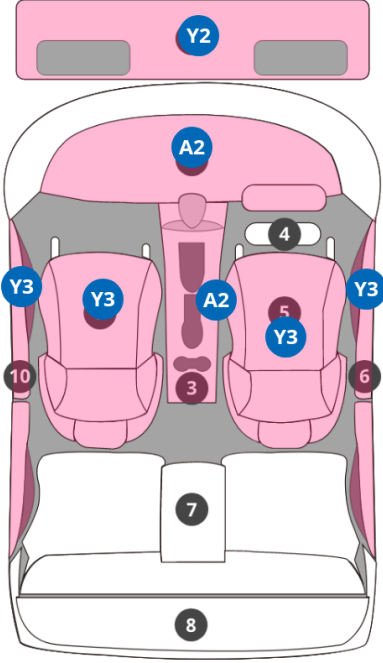
Interior Evaluation : C	Exterior Evaluation : D

<p>a : Cut, Fray d : Loose, Deformed k : Animal Hair s : Smell t : Cigarette Burns x : Defective y : Stain</p>

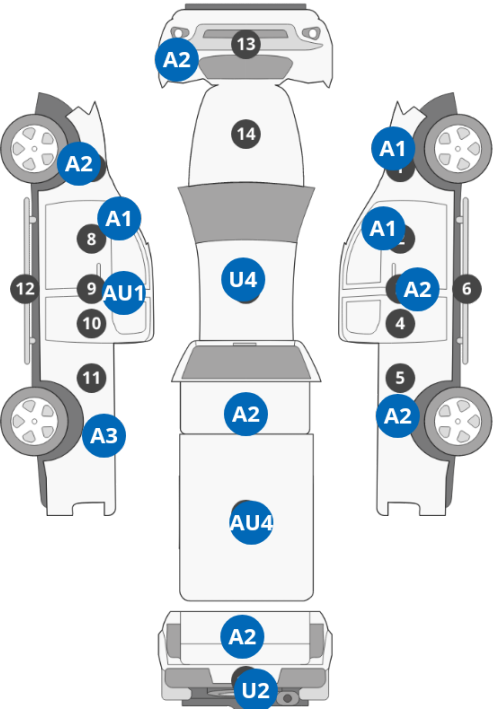
<p>A : Scratch AU : Scratch & Dent B : Modified C : Corrosion G : Stone chip P : Faded S : Rust SC : Rust & Corrosion U : Dent X : Defective Y : Crack, Gap</p>
Remarks (L) Front Seat - Grime - Medium / (R) Front Seat - Grime - Medium / Ceiling - Grime - Small / (R) Front Trim - Grime - Medium / (L) Front Trim - Grime - Medium / Dashboard - Worn, Scratch, Cut, Crack - Small / Console, Switches, Vents - Worn, Scratch, Cut, Crack - Small	Remarks (L) Center Panel - Scratch & Dent - Minimal / (L) Front Fender, Molding - Scratch - Small / (R) Front Fender, Molding - Scratch - Minimal / Front Bumper, Grille, Lamps - Scratch - Small / (R) Center Panel - Scratch - Small / Rear Gate - Scratch - Small / Rear Bumper, Lamps, Panels - Dent - Small / Cargo Bed Floor - Scratch & Dent - Large / (L) Side Gate - Scratch - Medium / (R) Side Gate - Scratch - Small / Roof - Dent - Large / Cab Back Panel - Scratch - Small / (L) Mirror - Scratch - Minimal / (R) Mirror - Scratch - Minimal

Inspector Notes
with LTO plate/with spare tire/No reverse camera/No spare key/No jack and tools/with warranty booklet/left and right front door traces of adhesive tape /left side tail light medium crack
