General Information

Make	Toyota	Model	Avanza
YOM	2025	Odo Meter Reading	7,262
Registration No.	DBU4873	Chassis No.	MHFAA1BY2S0041523
CC	1.3	Transmission	CVT
Fuel Type	Gas	Type of Body	Wagon
Colour	Green

Body / Panel Condition

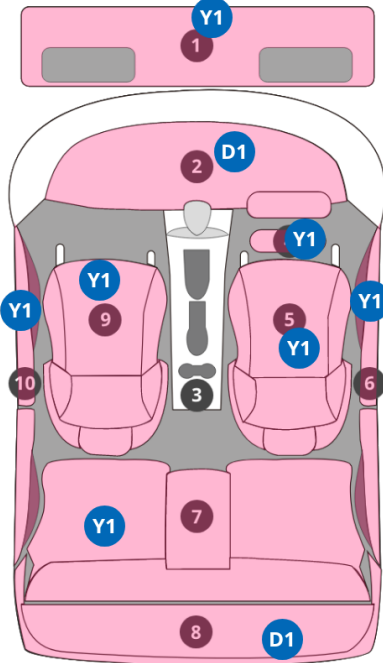
Interior Evaluation : A	Exterior Evaluation : E

<p>a : Cut, Fray d : Loose, Deformed k : Animal Hair s : Smell t : Cigarette Burns x : Defective y : Stain</p>

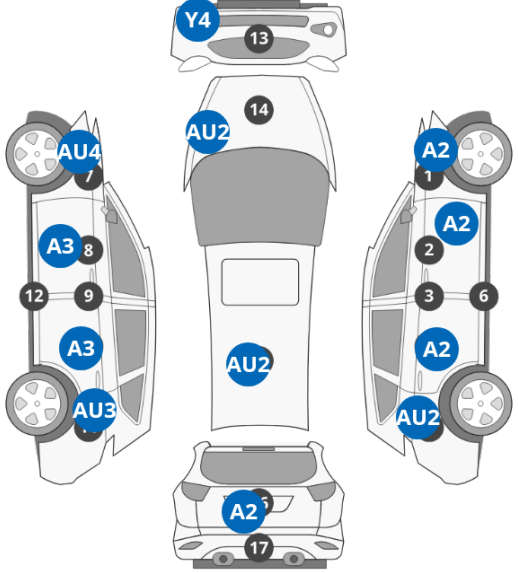
<p>A : Scratch AU : Scratch & Dent B : Modified C : Corrosion G : Stone chip P : Faded S : Rust SC : Rust & Corrosion U : Dent X : Defective Y : Crack, Gap</p>
<p>Remarks Ceiling - Grime - Minimal / (L) Front Trim - Grime - Minimal / (R) Front Trim - Grime - Minimal / (R) Front Seat - Grime - Minimal / (L) Front Seat - Grime - Minimal / Rear Seat - Grime - Minimal / Trunk Room - Worked - Minimal / Dashboard - Worked - Minimal / (L) Front Floor Mat - Grime - Minimal</p>	<p>Remarks (L) Front Fender, Molding - Scratch & Dent - Large / (L) Rear Door, Molding - Scratch - Medium / (L) Rear Fender, Molding - Scratch & Dent - Medium / Trunk Hood, Rear Gate - Scratch - Small / (R) Rear Fender, Molding - Scratch & Dent - Small / (R) Rear Door, Molding - Scratch - Small / (R) Front Door, Molding - Scratch - Small / (R) Front Fender, Molding - Scratch - Small / Bonnet, Headlight - Scratch & Dent - Small / Front Bumper, Grille, Lamps - Crack, Gap - Large / (L) Front Door, Molding - Scratch - Medium / Roof - Scratch & Dent - Small</p>
