General Information

Make	Suzuki	Model	Dzire
YOM	2022	Odo Meter Reading	90,763
Registration No.	LAK5596	Chassis No.	MBHZF6359NG173336
CC	1.2	Transmission	A/T
Fuel Type	Gas	Type of Body	Sedan
Colour	Blue

Body / Panel Condition

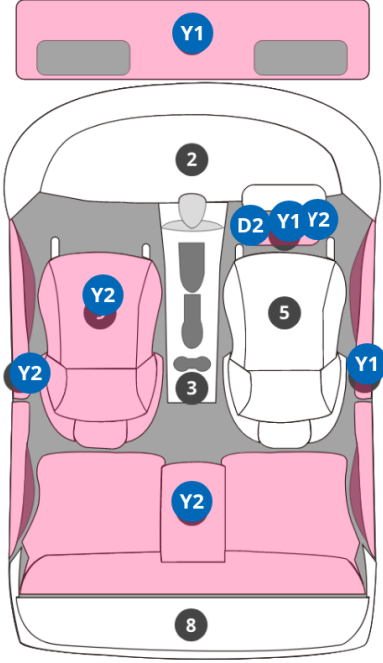
Interior Evaluation : B	Exterior Evaluation : E

<p>a : Cut, Fray d : Loose, Deformed k : Animal Hair s : Smell t : Cigarette Burns x : Defective y : Stain</p>

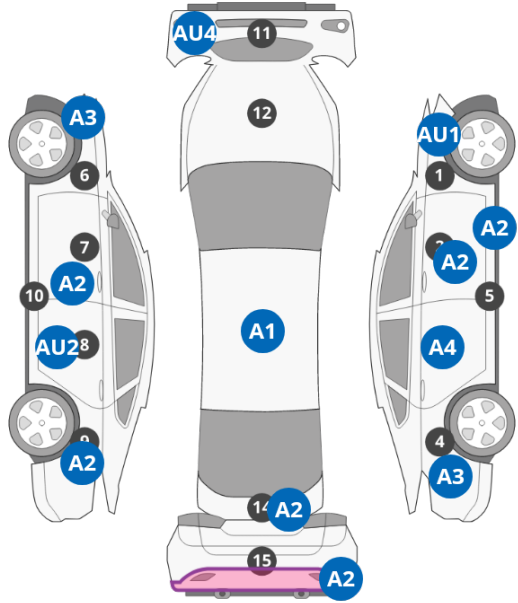
<p>A : Scratch AU : Scratch & Dent B : Modified C : Corrosion G : Stone chip P : Faded S : Rust SC : Rust & Corrosion U : Dent X : Defective Y : Crack, Gap</p>
<p>Remarks Rear Seat - Grime - Small / (R) Front Floor Mat - Grime - Small / (R) Front Trim - Grime - Minimal / Mat Other - Grime - Minimal / (L) Front Trim - Grime - Small / (L) Front Seat - Grime - Small / (L) Front Floor Mat - Worked - Small / Ceiling - Grime - Minimal</p>	<p>Remarks Front Bumper, Grille, Lamps - Scratch & Dent - Large / (L) Front Fender, Molding - Scratch - Medium / (L) Front Door, Molding - Scratch - Small / (L) Rear Door, Molding - Scratch & Dent - Small / (L) Rear Fender, Molding - Scratch - Small / Rear Bumper, Lamps, Panels - Repair mark - Yes / Trunk Hood, Rear Gate - Scratch - Small / Rear Bumper, Lamps, Panels - Scratch - Small / (R) Rear Fender, Molding - Scratch - Medium / (R) Rear Door, Molding - Scratch - Large / (R) Front Door, Molding - Scratch - Small / (R) Front Fender, Molding - Scratch & Dent - Minimal / (R) Step, In-panel, Side Spoiler - Scratch - Small / Roof - Scratch - Minimal</p>
