## General Information

| Make | Toyota | Model | Innova |

## Body / Panel Condition

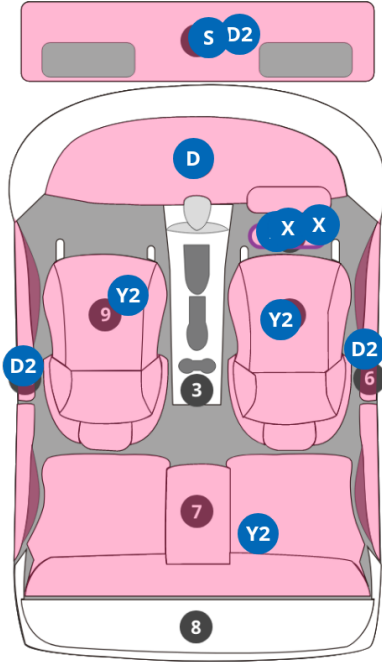
| Interior Evaluation : <b>B</b> | Exterior Evaluation : <b>D</b> |
| <b>Remarks</b><br>(L) Front Floor Mat - Missing - Yes / (R) Front Floor Mat - Missing - Yes / Mat Other - Missing - Yes / Rear Seat - Grime - Small / (R) Front Seat - Grime - Small / (L) Front Seat - Grime - Small / Dashboard - Traces of Adhesive Tape - Yes / Ceiling - Crinkle - Small / Overall Interior - Smell - Yes / (L) Front Trim - Worked - Small / (R) Front Trim - Worked - Small | <b>Remarks</b><br>(R) Front Fender - Repair Traces - Yes / Bonnet - Repair Traces - Yes / (L) Front Fender - Repair Traces - Yes / (R) Rear Door - Repair Traces - Yes / (R) Rear Door, Molding - Repair mark - Yes / (R) Front Fender, Molding - Repair mark - Yes / (L) Rear Door, Molding - Repair mark - Yes / (L) Front Fender, Molding - Repair mark - Yes / Bonnet, Headlight - Repair mark - Yes / Member (Bolted) - Dent - Yes / Front Bumper, Grille, Lamps - Repair mark - Yes / Front Bumper, Grille, Lamps - Scratch - Small / (L) Front Fender, Molding - Scratch - Minimal / (L) Mirror - Scratch - Minimal / (L) Front Door, Molding - Scratch - Minimal / (L) Step, In-panel, Side Spoiler - Scratch & Dent - Minimal / (L) Rear Door, Molding - Scratch & Dent - Minimal / (L) Rear Fender, Molding - Scratch - Small / (R) Front Fender, Molding - Scratch - Minimal / (R) Front Door, Molding - Scratch - Medium / (R) Rear Door, Molding - Scratch - Minimal / (R) Rear Fender, Molding - Scratch - Small / (R) Step, In-panel, Side Spoiler - Scratch & Dent - Small / Roof - Scratch & Dent - Small / Rear Bumper, Lamps, Panels - Scratch - Small / Trunk Hood, Rear Gate - Scratch - Minimal / Bonnet, Headlight - Scratch & Dent - Small |

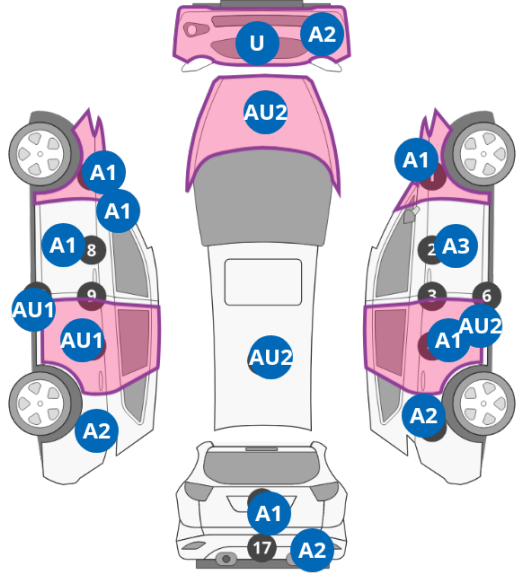
| Interior Evaluation : <b>B</b> | Exterior Evaluation : <b>D</b> |
|---|---|
| <b>Remarks</b><br>Front Cross Member Support - Traces of Bending, or Marks of Panel Repair ? - Yes / Right Front Inside Panel (Front Side) - Traces of Bending, or Marks of Panel Repair ? - Yes | <b>Remarks</b><br>Lamps (Brake, Tail, Fog) - Issue - Yes / Spare Key - Issue - Unexist |

| Inspector Notes |
|---|
| With LTO plate and Sparetire, No Tools and Jack and Warranty booklet, scratch headlight and tail light and worn tires, foglight missing, adhesive marks on vehicle, no spare key, plate light issue. |
