General Information

Make	Toyota	Model	Innova
YOM	2016	Odo Meter Reading	64,381
Registration No.	DEB1204-1	Chassis No.	TGN1403150005
CC	2.0	Transmission	A/T
Fuel Type	Gas	Type of Body	Wagon
Colour	Blackish Red Mica

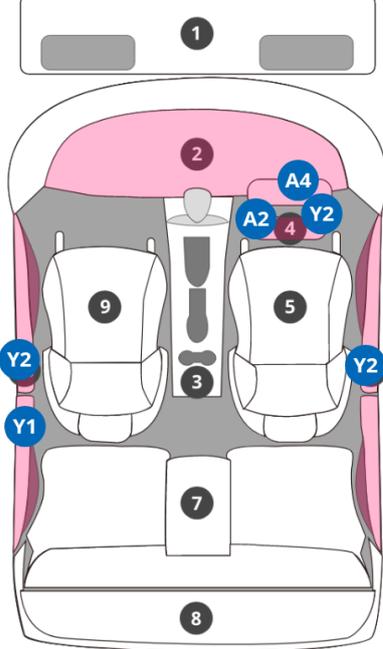
Interior Evaluation : C	Exterior Evaluation : D

<p>a : Cut, Fray d : Loose, Deformed k : Animal Hair s : Smell t : Cigarette Burns x : Defective y : Stain</p>

<p>A : Scratch AU : Scratch & Dent B : Modified C : Corrosion G : Stone chip P : Faded S : Rust SC : Rust & Corrosion U : Dent X : Defective Y : Crack, Gap</p>
<p>Remarks Steering Wheel - Worn, Peel, Crack - Large / (R) Front Trim - Grime - Small / (L) Front Trim - Grime - Small / (L) Rear Trim - Grime - Minimal / (L) Front Floor Mat - Cut, Crack - Small / (R) Front Floor Mat - Grime - Small</p>	<p>Remarks Front Bumper, Grille, Lamps - Scratch & Dent - Large / (R) Front Fender, Molding - Scratch & Dent - Large / (R) Mirror - Faded(Color, Gloss) - Yes / (R) Front Door, Molding - Scratch & Dent - Small / (R) Rear Door, Molding - Scratch - Minimal / (R) Rear Fender, Molding - Scratch - Small / Rear Bumper, Lamps, Panels - Scratch - Medium / (L) Rear Fender, Molding - Scratch - Small / (L) Rear Door, Molding - Scratch - Small / (L) Front Door, Molding - Scratch - Small / (L) Mirror - Faded(Color, Gloss) - Yes / (L) Front Fender, Molding - Scratch & Dent - Small / Bonnet, Headlight - Scratch - Minimal</p>
