General Information

Make	Toyota	Model	Vios
YOM	2024	Odo Meter Reading	14,753
Registration No.	DBM8964	Chassis No.	PA1B18F34R4242855
CC	1.3	Transmission	CVT
Fuel Type	Gas	Type of Body	Sedan
Colour	Blue

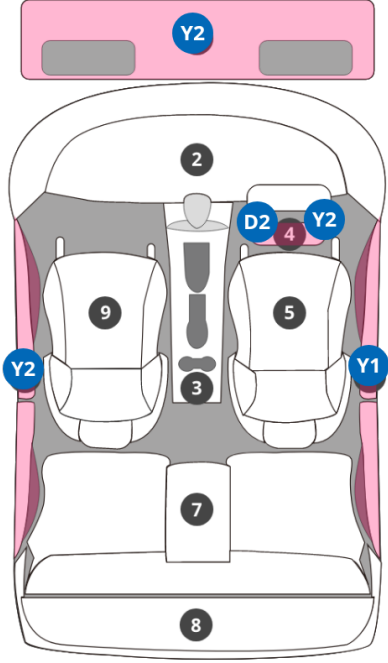
Interior Evaluation : B	Exterior Evaluation : E

<p>a : Cut, Fray d : Loose, Deformed k : Animal Hair s : Smell t : Cigarette Burns x : Defective y : Stain</p>

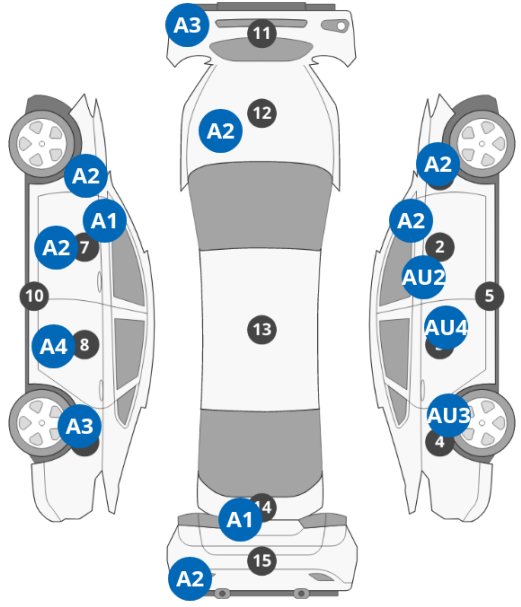
<p>A : Scratch AU : Scratch & Dent B : Modified C : Corrosion G : Stone chip P : Faded S : Rust SC : Rust & Corrosion U : Dent X : Defective Y : Crack, Gap</p>
<p>Remarks Ceiling - Grime - Small / (L) Front Trim - Grime - Small / (L) Front Floor Mat - Worked - Small / (R) Front Floor Mat - Grime - Small / (R) Front Trim - Grime - Minimal</p>	<p>Remarks (L) Front Fender - Repair Traces - Yes / (L) Front Door - Repair Traces - Yes / (L) Step - Repair Traces - Yes / (R) Rear Door, Molding - Scratch & Dent - Large / (R) Front Door, Molding - Scratch & Dent - Small / (R) Rear Fender, Molding - Scratch - Scratch & Dent - Medium / (R) Mirror - Scratch - Small / (L) Rear Fender, Molding - Scratch - Medium / Trunk Hood, Rear Gate - Scratch - Minimal / Rear Bumper, Lamps, Panels - Scratch - Small / (L) Rear Door, Molding - Scratch - Large / (L) Front Door, Molding - Scratch - Small / (L) Mirror - Scratch - Minimal / (L) Front Fender, Molding - Scratch - Small / Bonnet, Headlight - Scratch - Small / Front Bumper, Grille, Lamps - Scratch - Medium / (R) Front Fender, Molding - Scratch - Small</p>
