## General Information

| Make | Mitsubishi | Model | Mirage |
| Registration No. | GAV1288 | Chassis No. | PAEA13RJMMMA021665 |

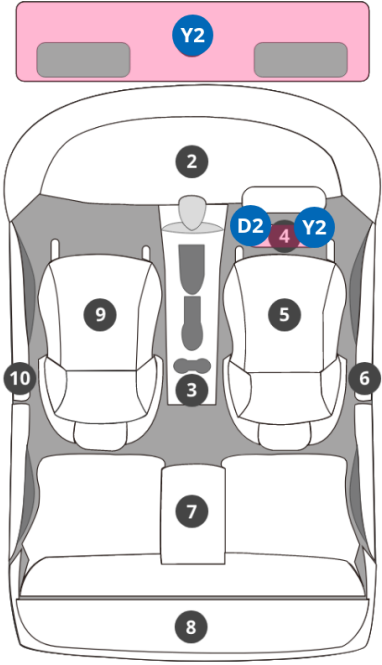
| Interior Evaluation : <span style="color: red; font-weight: bold;">A</span> | Exterior Evaluation : <span style="color: red; font-weight: bold;">D</span> |
| <b>Remarks</b><br>(R) Front Floor Mat - Grime - Small / Ceiling - Grime - Small / (L) Front Floor Mat - Worked - Small | <b>Remarks</b><br>(R) Rear Door, Molding - Scratch & Dent - Small / (R) Front Door, Molding - Dent - Small / (R) Rear Fender, Molding - Scratch - Small / Rear Bumper, Lamps, Panels - Repair mark - Yes / Rear Bumper, Lamps, Panels - Crack, Gap - Large / Trunk Hood, Rear Gate - Scratch - Small / (L) Rear Fender, Molding - Scratch - Small / (L) Rear Door, Molding - Scratch & Dent - Medium / (L) Front Door, Molding - Scratch - Small / Bonnet, Headlight - Scratch & Dent - Small / (L) Front Fender, Molding - Scratch - Small / Front Bumper, Grille, Lamps - Scratch & Dent - Small / (R) Front Fender, Molding - Scratch - Minimal / (R) Mirror - Scratch - Small / Roof - Repair mark - Yes / Roof - Scratch - Small |
