General Information

Make	Nissan	Model	Terra
YOM	2019	Odo Meter Reading	63,774
Registration No.	FAE8160	Chassis No.	MNTJCAD23Z0009230
CC	2.5	Transmission	M/T
Fuel Type	Diesel	Type of Body	SUV
Colour	Silver

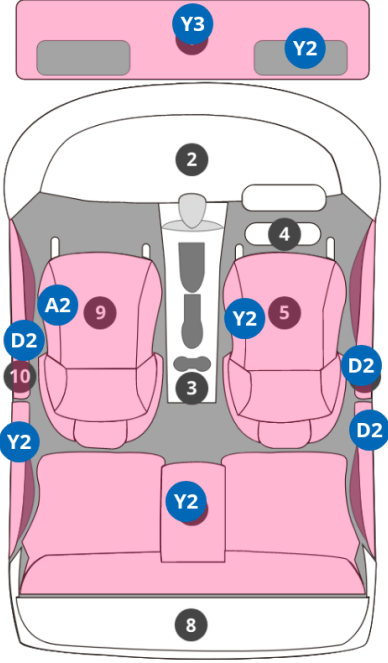
Interior Evaluation : C	Exterior Evaluation : E

<p>a : Cut, Fray d : Loose, Deformed k : Animal Hair s : Smell t : Cigarette Burns x : Defective y : Stain</p>

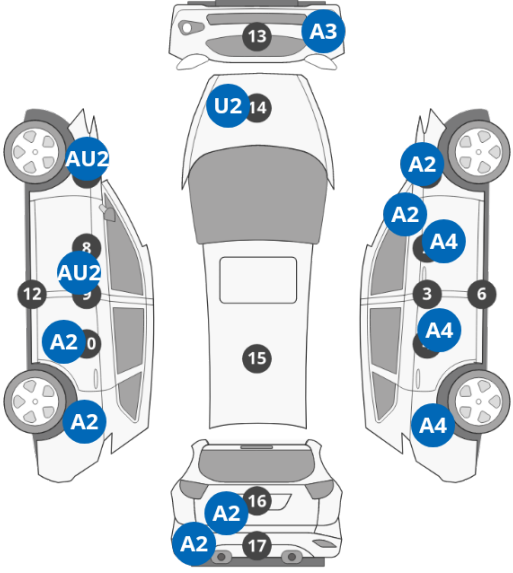
<p>A : Scratch AU : Scratch & Dent B : Modified C : Corrosion G : Stone chip P : Faded S : Rust SC : Rust & Corrosion U : Dent X : Defective Y : Crack, Gap</p>
<p>Remarks Rear Seat - Grime - Small / (L) Rear Trim - Grime - Small / (L) Front Trim - Worked - Small / (L) Front Seat - Cut, Crack - Small / Ceiling - Grime - Medium / Sunvisor, Sunglass Holder - Grime - Small / (R) Front Trim - Worked - Small / (R) Front Seat - Grime - Small / (R) Rear Trim - Worked - Small</p>	<p>Remarks (R) Front Door - Repair Traces - Yes / (R) Step - Repair Traces - Yes / (R) Front Fender - Repair Traces - Yes / Bonnet - Repair Traces - Yes / (L) Front Fender - Repair Traces - Yes / (L) Front Door - Repair Traces - Yes / (L) Step - Repair Traces - Yes / (L) Rear Door - Repair Traces - Yes / (L) Rear Fender - Repair Traces - Yes / Trunk Hood, Rear Gate - Repair Traces - Yes / (R) Rear Fender - Repair Traces - Yes / (R) Rear Door - Repair Traces - Yes / Roof - Repair Traces - Yes / (R) Rear Door, Molding - Scratch - Large / (R) Rear Fender, Molding - Scratch - Large / (R) Front Door, Molding - Scratch - Large / (R) Mirror - Scratch - Small / (R) Front Fender, Molding - Scratch - Small / Bonnet, Headlight - Dent - Small / Front Bumper, Grille, Lamps - Scratch - Medium / (L) Front Fender, Molding - Scratch & Dent - Small / (L) Rear Door, Molding - Scratch - Small / (L) Rear Fender, Molding - Scratch - Small / Rear Bumper, Lamps, Panels - Scratch - Small / Trunk Hood, Rear Gate - Scratch - Small / (L) Front Door, Molding - Scratch & Dent - Small</p>
